Prescriptive Details for Wind Resistant Envelopes based on Observations of Newly Built Homes Damaged in 2011 TORNADOS

Authors: Bryan Readling ¹, P.E., Edward Keith ², P.E.

APA

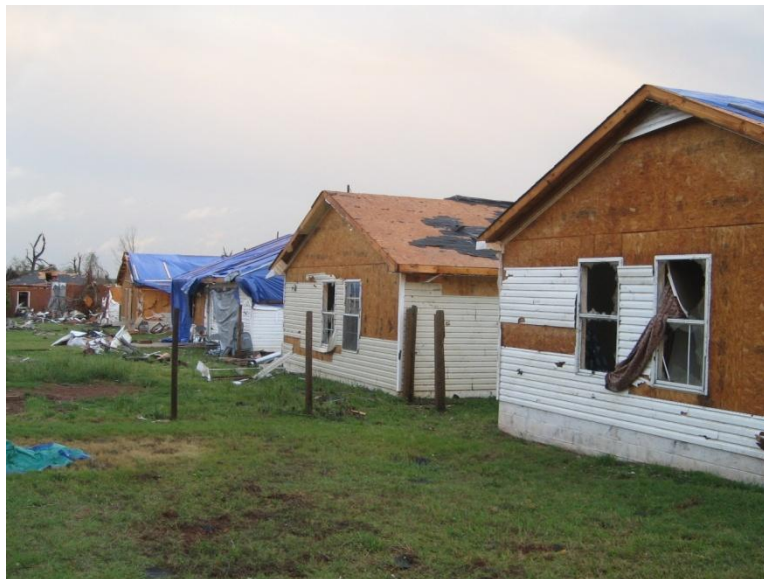
Another common theme observed along the tornado paths is that homes constructed with non-structural exterior wall sheathing, especially if used in conjunction with vinyl siding, failed at wind speed much lower than called for in the building codes. Walls that are fully sheathed with OSB or plywood and constructed with proper connections have stronger resistance to the damaging forces of high winds and even when siding has been lost still offer strength and weather protection.

Figure 1 –Building Envelopes Fully Sheathed with Wood Structural Panels.

7. **Continuously sheath all walls with wood structural panels including areas around openings for windows and doors.** *Comments: Continuous wood structural panel wall sheathing on the entire building exterior improves redundancy and resistance to wind-borne debris during high-wind events. Since all wall, floor, and roof elements are restrained by attachment to adjacent diaphragm elements, buildings constructed in this manner behave more like a box, and less like a collection of independent plates. In addition, the use of continuous sheathing provides both strength and protection if the exterior siding is blown off or damaged by flying debris.*

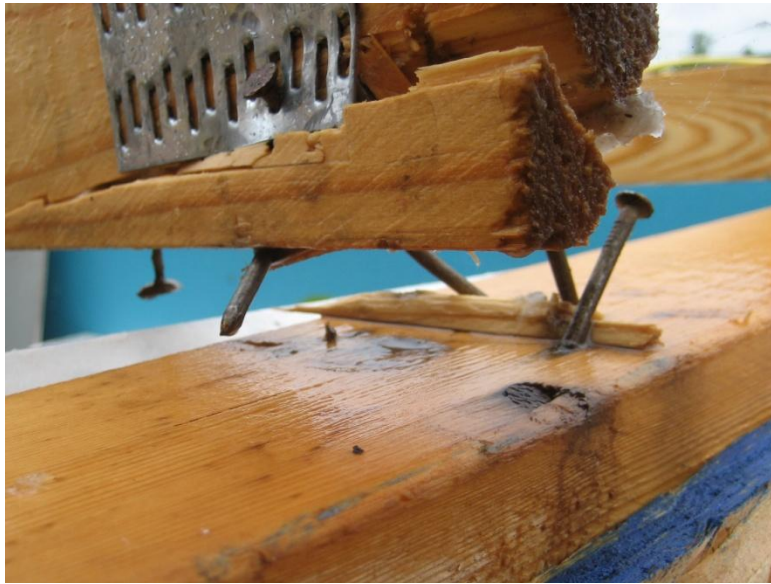
In a field survey of damaged structures, APA observations indicated that structural failure along the critical load-path was often located at the roof-to-wall connection. Most of these connections were made using toe-nails through the roof framing and into the top plate of the exterior walls. Toe-nail connections are weak because they rely upon the withdrawal capacity of nails, which is limited. Light-gauge metal connectors provide good performance in wood framing because load is applied perpendicular to the nail shank, instead of pulling the nail straight out. Toe-nail rafter connections are still prescriptively allowed in most non-hurricane areas by modern building codes through “grandfathered” language. It is generally recognized that these connections do not provide the capacity to resist the range of pressure requirements of the *International Building Code*.

Figure 2. Toe-nailed Connection of Roof Framing-to-Wall.

- 4. For the roof framing-to-wall connection, use a hurricane anchor attached on the exterior (sheathing side) of the exterior walls.** *Comments: The roof-to-wall connection under high wind loads is subject to both uplift and shear. For this reason the best option is to use a connector that is intended to provide restraint in all 3 directions such as the H1 connector by Simpson Strong-Tie. A simple twist-strap may also be used for the uplift component in combination with toenails to provide lateral restraint.*

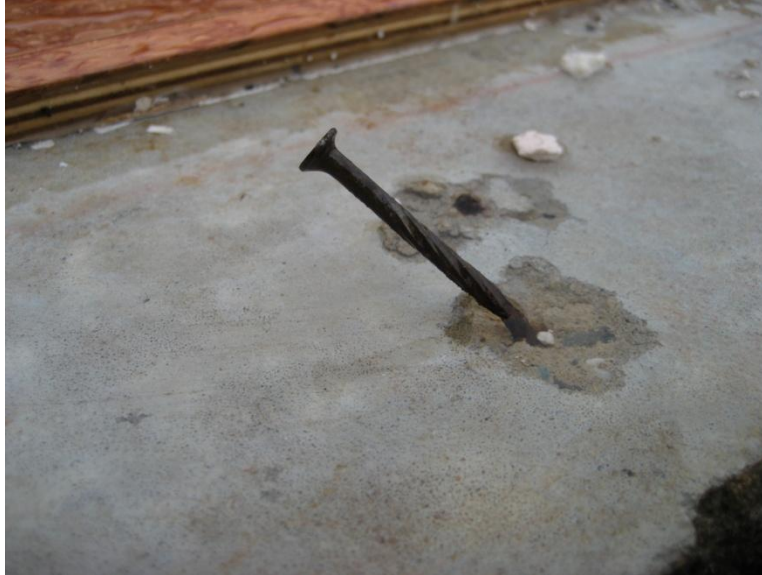
In each of these tornado outbreaks, regardless of the tornados intensity, anchorage of the exterior walls to the foundation was most often the difference between a structure that continued to provide some level of protection to occupants, or one that was swept clean from the foundation. Among severely damaged homes it was observed that wall-to-foundation anchorage was often woefully inadequate. In many of these cases roofs and walls were strongly built, but poor connections to the foundation resulted in sudden and catastrophic failure. In many cases hand-driven cut masonry nails were used to attach the bottom of support walls to the concrete or masonry foundations. In some cases the nails were observed to be pneumatically-driven framing nails. Modern building codes generally require anchor-bolts to be embedded into concrete or grouted concrete masonry units.

Figure 3 – Failed Nail Connection of Wall Bottom-Plate to Slab.

8. **Extend wood structural panel sheathing to lap the sill plate which is bolted to the slab or foundation-wall.** *Comments: Nailing of the wall sheathing panels to the sill plate is important because this is where uplift forces are transferred into the foundation through the anchor bolts. Too often bottom sill-plates are observed to be the only remaining wall element still attached to the foundation. Nailing the wall sheathing to the sill plate utilizes the nails in shear and provides an economical, strong, and redundant attachment at this point along the load-path.*

9. **Space ½ in. anchor bolts 32 inches to 48 inches on center with 0.229 in. x 3 in. x 3 in. square plate washers with slotted holes.** *Comments: Plate washers of this size are able to incorporate most of the bottom-plate width and more effectively prevents cross-grain stresses and splitting from occurring in the bottom plate material. Tests performed by APA prior to the tornados scrutinized anchor bolt spacing for use in the engineering of walls sheathed with plywood or OSB and subjected to simultaneous shear (racking) and uplift wind and seismic forces. The results revealed tremendous gains in capacity of walls with more closely spaced anchors when used in conjunction with larger 3" x 3" plate washers.*

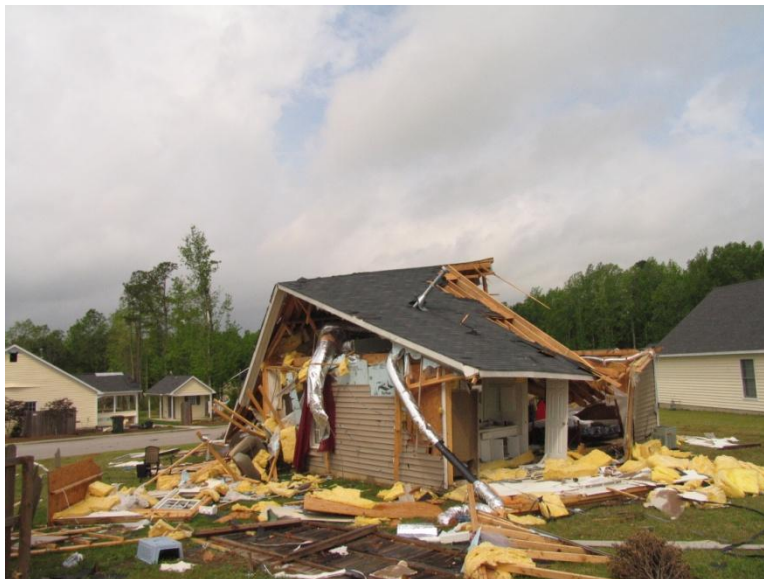
Breaches or openings in the building envelope, and the resulting pressurization of the building interior caused catastrophic failure of homes in many examples. Openings in walls due to failure of doors, windows, and cladding systems were common. These often resulted in heavy damage to home interiors due to rainwater infiltration and flying debris penetration. Larger breaches from loss of weak garage doors and exterior cladding systems often acted to initiate catastrophic failure and exacerbated deficiencies along the aforementioned load-path.

Figure 4 – Envelope Failure of Foam Sheathed Exterior Walls

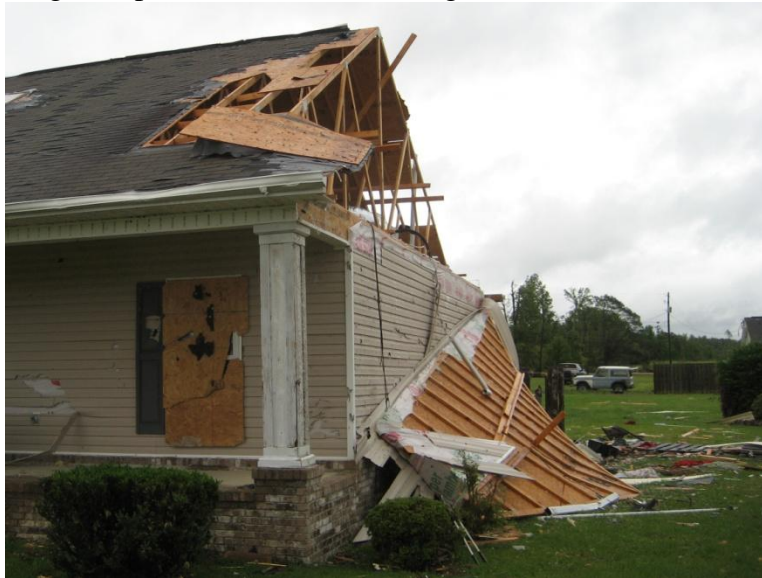
In homes with gable roofs, failures were most notable at the bottom of the gable-end roof and ceiling framing where they are connected to the top of the gable-end wall below. This joint is often not well connected laterally to the rest of the building and is weak to resist negative pressure on the exterior gable-end surfaces.

Figure 5 – Failure of Gable-end Framing.

- 3. Tie gable end walls back to the structure using continuous lateral braces 6'-0" on center on top of the ceiling framing and connecting these to the gable-end wall using steel straps nailed on each side of the connection using (8) 10d common nails.** *Comments: One of the weakest links in residential structures during high wind events is the connection between the roof gable-end and the wall below. The prescriptive codes provide no guidance on how to properly attach these two important elements and failures at this joint are, unfortunately, quite common. Construction details that have been developed to properly secure and tie back a gable end may be used. Also common in high wind areas is to eliminate the gable through the use of hip roofs or, if the gable is an architectural necessity, use balloon framing. (Detail courtesy of Standard for Hurricane Resistant Residential Construction, SSTD 10-93 Section 306.4.2.)*

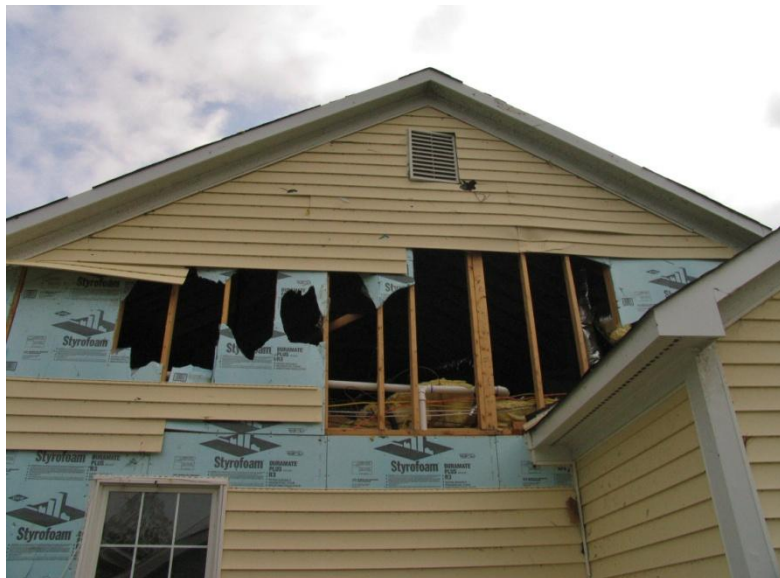
The gable-end is also a vulnerable location for cladding systems since walls within the roof cavity are not backed by drywall like the exterior walls within the living space. Material failure was commonly observed when non-structural foam wall sheathing was used in conjunction with low-strength siding. Besides vulnerability to wind pressure, these products provide little resistance to the flying debris.

Figure 6 – Non-Structural Sheathing at Gable-end after minor wind event.

- 2. Sheath gable end walls with wood structural panels, such as plywood or oriented strand board (OSB).** *Comments: Gable end wall failures are frequently observed when non-structural sheathing is used. Most non-structural foam sheathing materials are required to be used in conjunction with gypsum wall board inside of the house. This is frequently neglected in the construction of gable end walls. The easiest way to avoid the need of installing interior gypsum at the gable end walls is to use wood structural panel sheathing on the exterior.*

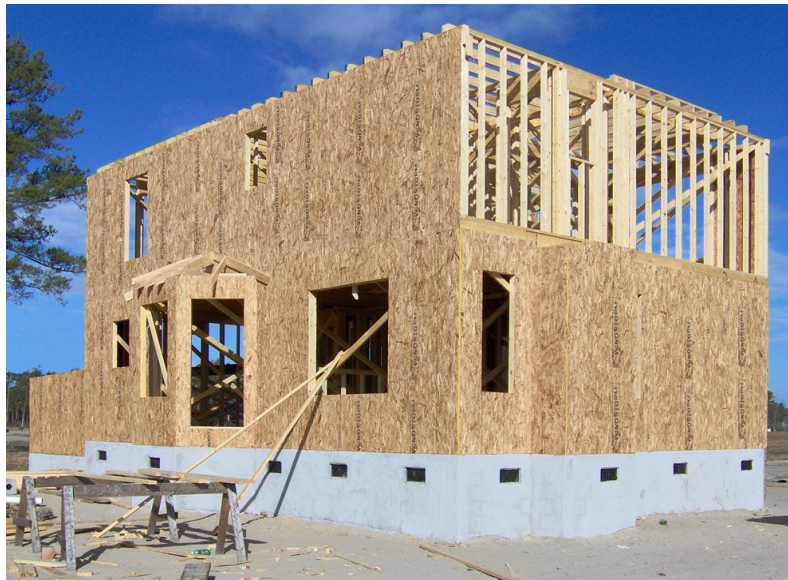
Figure 7 – With thoughtful layout, continuous structural sheathing can resist both shear and uplift forces, providing cost-effective continuity between the foundation and roof framing connections. Oversize panels may be used to eliminate blocking by locating horizontal panel joints at the rim joists and to match the dimensions of taller wall systems.

6. **Nail upper story sheathing and lower story sheathing into common wood structural panel Rim Board®.** *Comments: The most effective way to provide lateral and uplift load continuity is to enlist the use of continuous wall sheathing to bridge joints in the wall plane. Long length OSB Rim Board can be used as this common framing member to ensure shear and uplift continuity, which eliminates the need for horizontal blocking. Being at least 9-1/2" in depth and 1" in thickness, commonly available Rim Board makes an excellent "target" for mating adjacent panels. Otherwise horizontal blocking may be utilized at panel joints to enhance continuity in wall sheathing panels. For use around windows and doors or as an alternative to this detail, metal strap anchors designed for such applications may be used. For designed applications, additional information is available in APA Data File: Shear Transfer at Engineered Wood Floors, Form Y250.*
