Residential Damage Patterns Following the 2011 Tuscaloosa, AL and Joplin, MO Tornadoes

D. B. Roueche¹ and D. O. Prevatt¹

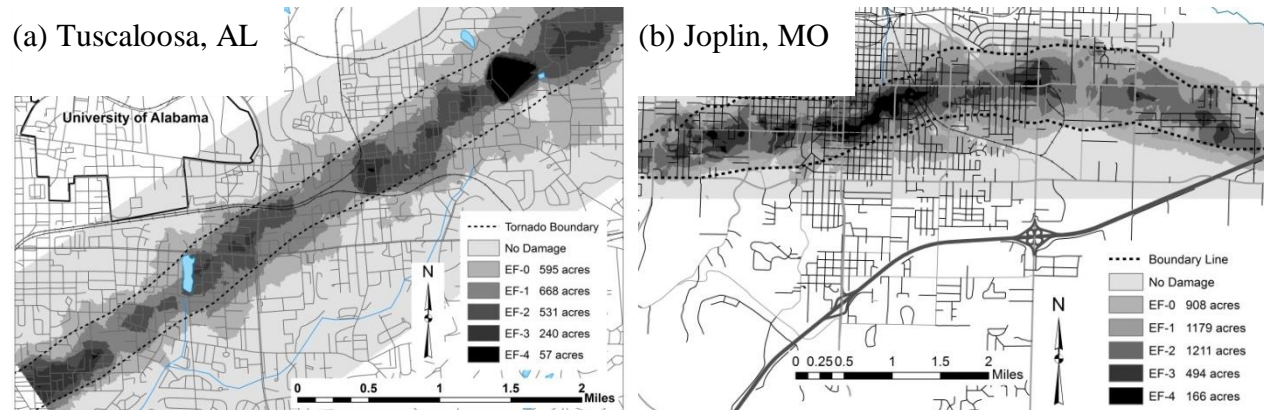
Figure 2: Wind Speed Distributions within the Tuscaloosa and Joplin Tornadoes

By relating the estimated wind speed from the damage at each home to the location of the home, a more precise estimate of the distribution of wind speeds throughout the tornado wind-fields was obtained. Contour plots of the estimated wind speeds for each tornado were developed and are shown in Figure 2.

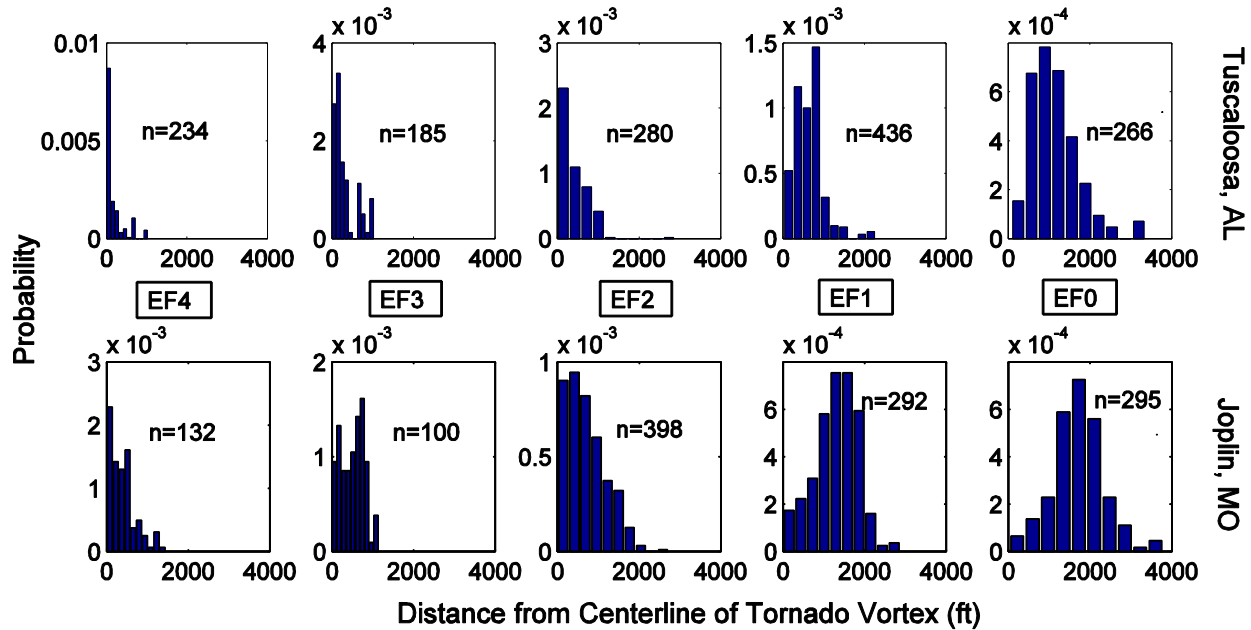
Figure 3: Distributions of Wind Speed within the Tornado Wind-field

Further analysis of the distribution of wind speeds was performed by determining the distance from the estimated centerline of the tornado vortex to each rated building (and therefore estimated wind speed) in both Tuscaloosa and Joplin. The results of this analysis are plotted as normalized histograms in Figure 3, illustrating the distribution of wind speeds within the complete damage path. Box plots are also used in Figure 4 to depict the median, 25th and 75th percentiles of the distributions, with EF-1 representing homes with no observed damages. The “+” data marker represents data that falls outside of ± 2.7 standard deviations from the mean. It is possible that such outliers represent the locations of secondary vortices, but other options such as undocumented tree damage should also be considered.

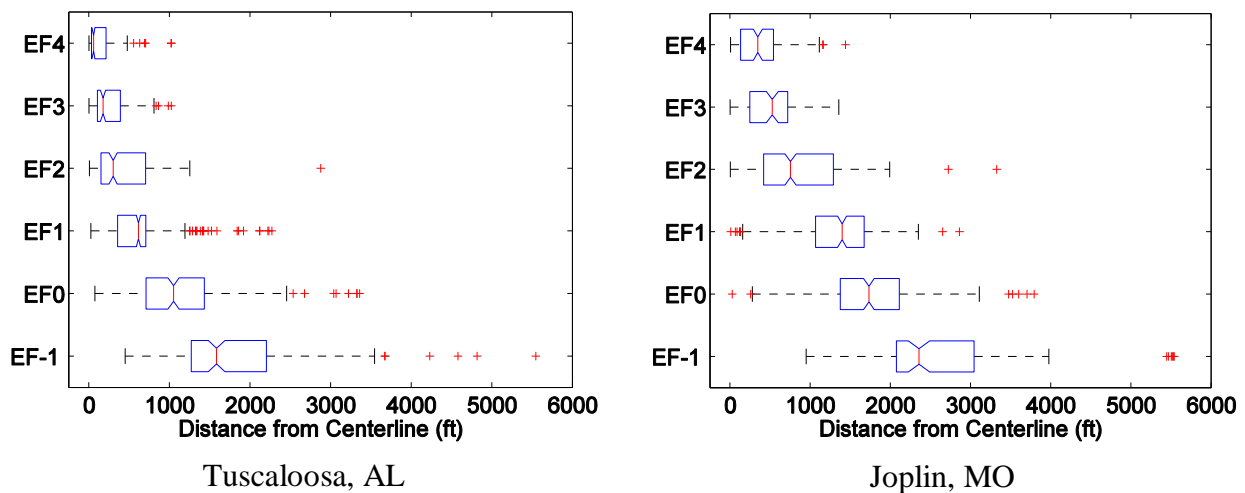
Figure 4: Distribution of Damages around Centerline

Differences in the characteristics of the two tornadoes are apparent from these plots of the observed damages. While the maximum size of both tornadoes is similar (nearly 4,000ft radius, assuming equal distances each side of the centerline), the median values for each EF-scale rating are much more compact in the Tuscaloosa tornado than in the Joplin tornado. These distributions of damages around the centerline were analyzed to empirically develop a model of the changes in wind speed with increasing distance from the vortex. The midpoint value within the range of wind speeds attributed to each EF Scale intensity was paired with the median distances from the vortex that are presented in Figure 4. Wind speed as a function of this distance from the edge of

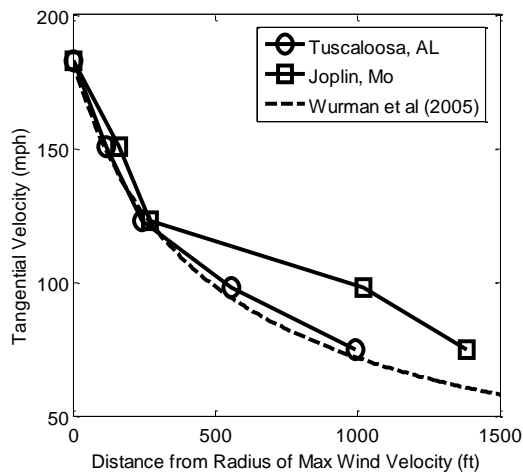
Figure 5: Comparison of Wind Speeds with Distance from Vortex

of the vortex is typically modeled as a Rankine vortex, with $V(r) = (V_{max}) * (R/r)^a$, where V_{max} represents the maximum tangential velocity, R the radius to maximum wind velocity, r the radial distance from the center of the vortex, and a the decay coefficient, estimated to vary from 0.5 to 1.0. Wurman et al estimated a decay coefficient of 0.67 for the F4 tornado in Spencer, South Dakota (Wurman e Curtis, 2005), and this estimate is compared in Figure 5 to the empirically developed model, assuming the same maximum wind speed for all three models. The comparison demonstrates good agreement between the model observed by Wurman et al using Doppler radar and the empirically developed models from the damage assessments, particularly for the Tuscaloosa tornado. While it is

possible that the exceptional agreement between the Tuscaloosa model and the observations by Wurman et al in the Spencer tornado is entirely coincidental, it suggests that the behavior of the boundary layer wind speeds in a large tornado is similar to that observed by Doppler in the upper atmosphere.

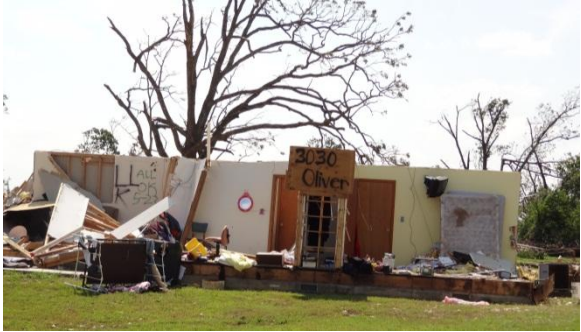
<p><i>Multiple Wall Collapse</i> Collapse of more than one wall, including complete collapse of all walls.</p>

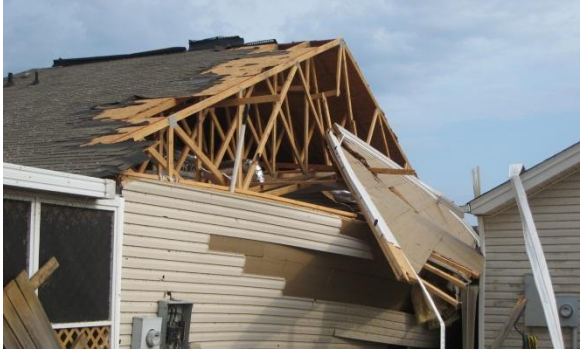
<p><i>Gable Failure</i> Collapse of the gable truss or separation of the gable truss from the gable wall below. This damage mechanism was documented due to previous studies which have shown that a significant portion of the vertical load throughout the roof system is transferred to the walls through the gable end. (Datin, Mensah <i>et al.</i>, 2010)</p>

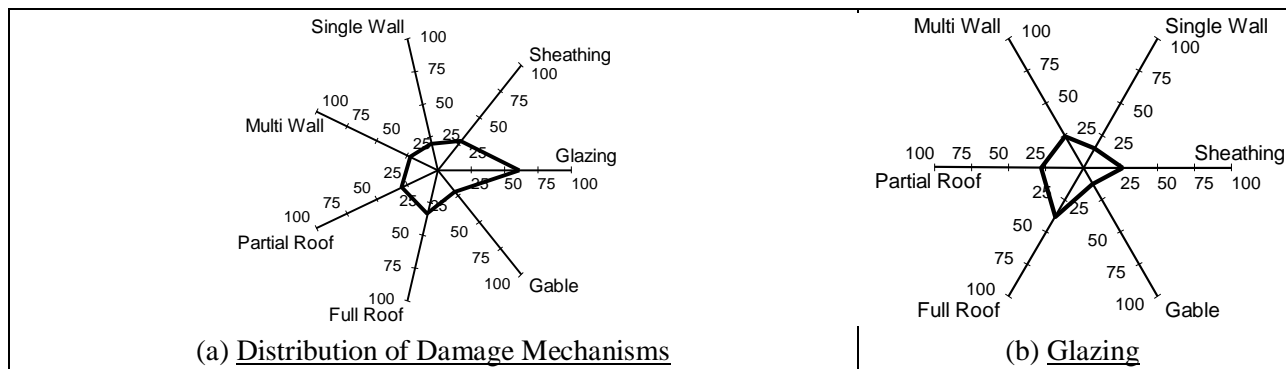
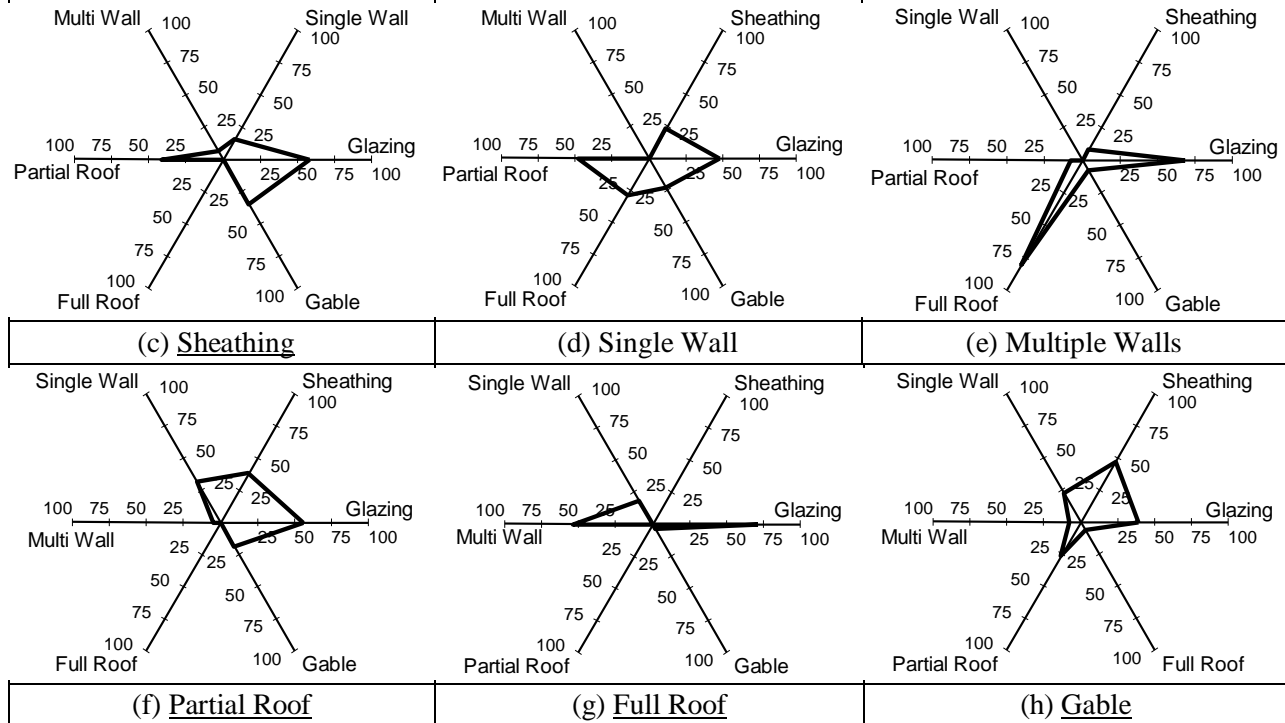
Table 2: Observed Failure Patterns in Wood-frame Homes

The subset of 244 wood-frame residential structures was analyzed to identify which failure mechanisms were present and the results are illustrated in Table 2 below. In the majority of the structures multiple failure mechanisms were identified. The overall distribution of failure mechanisms within this subset is illustrated by percentage in (a). Further, in each spider-web diagram (a) through (g) the association of each failure mechanism is analyzed showing their percentage frequency of occurrence, with which it was associated with the other defined failures.

- 1) The most prevalent failure mechanism is the failure of glazing (50%) Table 2(a), which is to be expected given the large, circulating debris cloud associated with tornadoes.

- 2) The collapse of multiple walls was the most highly correlated (at 81%) with full removal of the roof, Table 2(d), illustrating the importance of the roof diaphragm in overall stability of the house. Of the homes that were observed to have multiple wall collapse, 81% were associated with full removal of the roof as well. This again illustrates the importance of the roof diaphragm in the support of the walls. Without the support of the roof diaphragm, the exterior walls function as inadequately fixed cantilevers and are prone to collapse. Interior walls could serve to provide additional interior support but in typical construction minimal attachment if any is used to connect the interior and exterior walls.

- 3) With nearly 60% of the homes experiencing envelope breaches of some kind, it is probable that internal pressures played a significant role in the final damages. Of the homes that experienced full roof removal, nearly 75% of them also had breaches in the envelope whether due to glazing fracture or door failure. Perhaps this should be expected given the large, fast-circulating debris clouds associated with tornadoes. But such breaches in buildings suffering full roof removal and multiple wall collapse occur 20% more often than in the other defined damage mechanisms. This suggests a failure pattern of glazing breach → buildup of internal pressures → full roof removal → multiple wall collapse.

- 4) Gable failures were associated with roof sheathing removal in nearly 50% of the observed homes. While not as strong a correlation as the others, it suggests an intuitive

failure pattern in which the loss of sheathing, typically along the gable wall in the ASCE 7 edge zones, can weaken the support of the gable truss and allow it to collapse.

The results of this analysis provide insight into what should be the primary areas of focus for tornado-resistant design. As discussed previously, the protection of the roof diaphragm is vital to maintaining the structural integrity of the home during a tornado, and this is validated by the results. In homes in which multiple walls collapsed, full roof removal occurred in 81% of the cases. The use of stronger roof-to-wall connections such as the metal ties used in hurricane-prone regions could significantly reduce the number of buildings that experience total collapse by strengthening the roof-to-wall connections and maintaining the structural integrity of the roof diaphragm.

With nearly 60% of the homes being identified with breaches in the envelope, it is obvious that unless debris-impact glazing and strengthened doors are used, the impact of internal pressures cannot be overlooked in design. Moreover with the significant debris-cloud and high winds associated with tornadoes, it may be necessary from a tornado design standpoint to design for internal pressures in addition to providing a certain level of debris-impact glazing.
