Superstorm Sandy Storm Surge and Residential Damage Correlation – A case study of Long Beach, NY

N.L. Braxtan, Ph.D.¹, K. Donohue-Couch, M.S., P.E.², and K. Westphal³

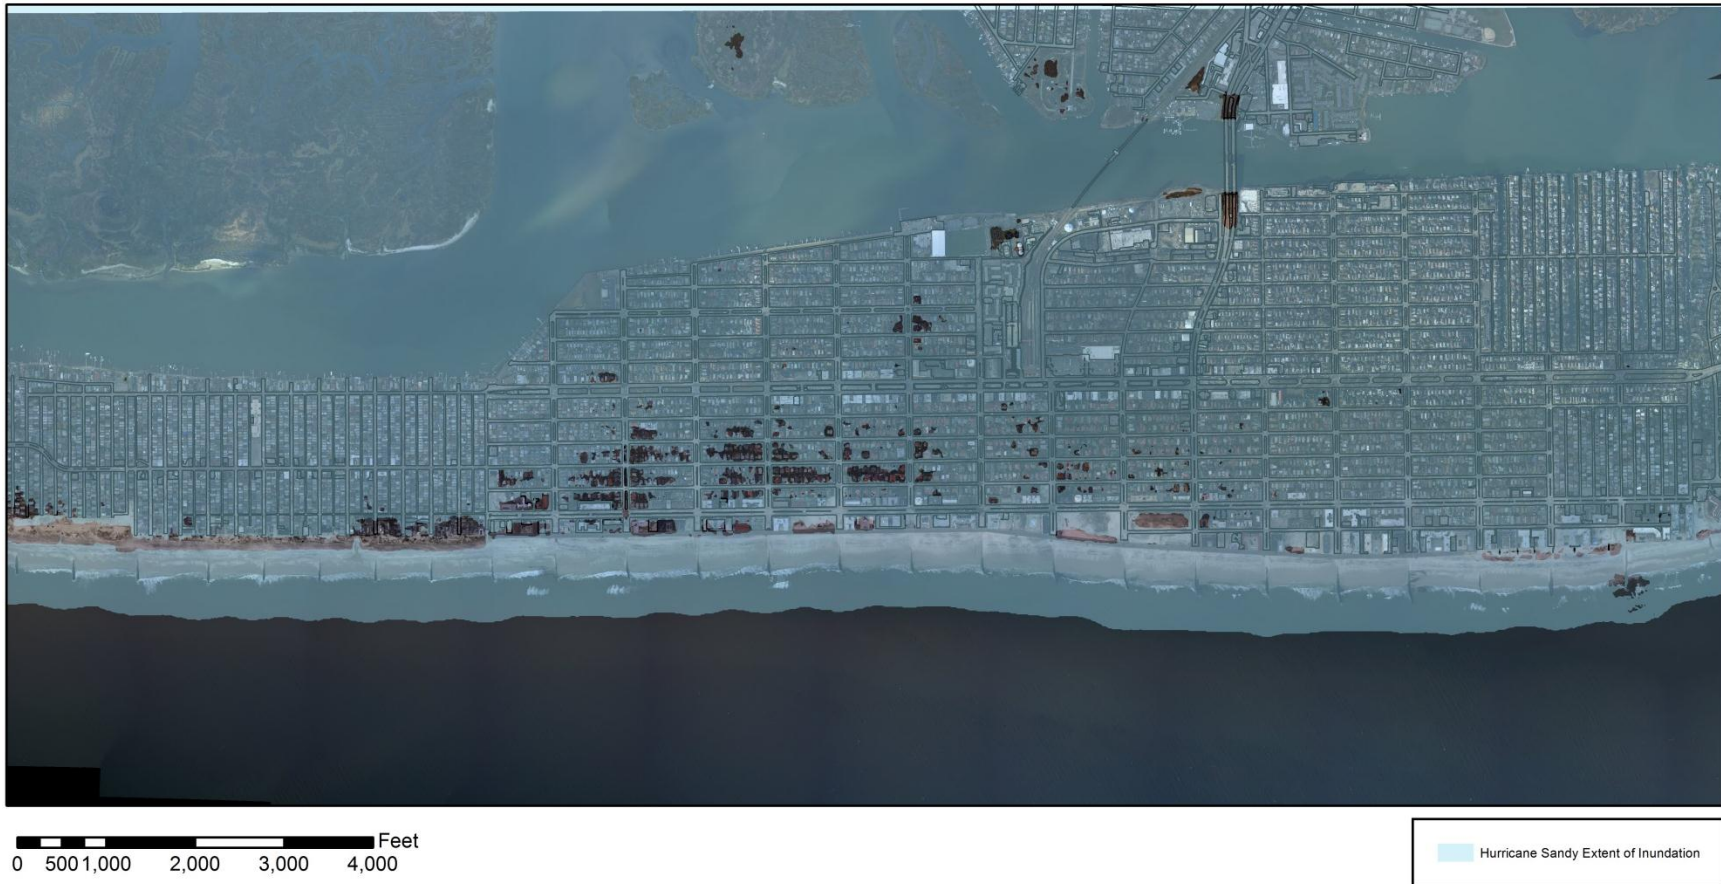
Figure 2 – Aerial Map of Long Beach showing the Population Density and extent of Superstorm Sandy Water Inundation

The compiling of this type of data was initially narrowed down to one coastal city – the City of Long Beach in Nassau County, Long Island, as pictured in Figure 1. Long Beach is just 18 miles southeast of Battery Park, Manhattan, New York City, and borders the communities of Atlantic Beach on the west, Lido Beach on the east, the Atlantic Ocean on the south, and the Reynolds Channel portion of the intercoastal waterway to the north. It has a 30,000 year-round population, which increases in the summer months. Figure 2 is an aerial map of Long Beach, illustrating that it is a densely populated beach community on the barrier island. Figure 2 also shows the extent of the storm surge from Superstorm Sandy. Almost all of Long Beach was flooded (shown in gray). The dark shaded areas near the bridge going over the intercoastal channel, and small spots in the south-west part of the city were the only locations that were spared water inundation.

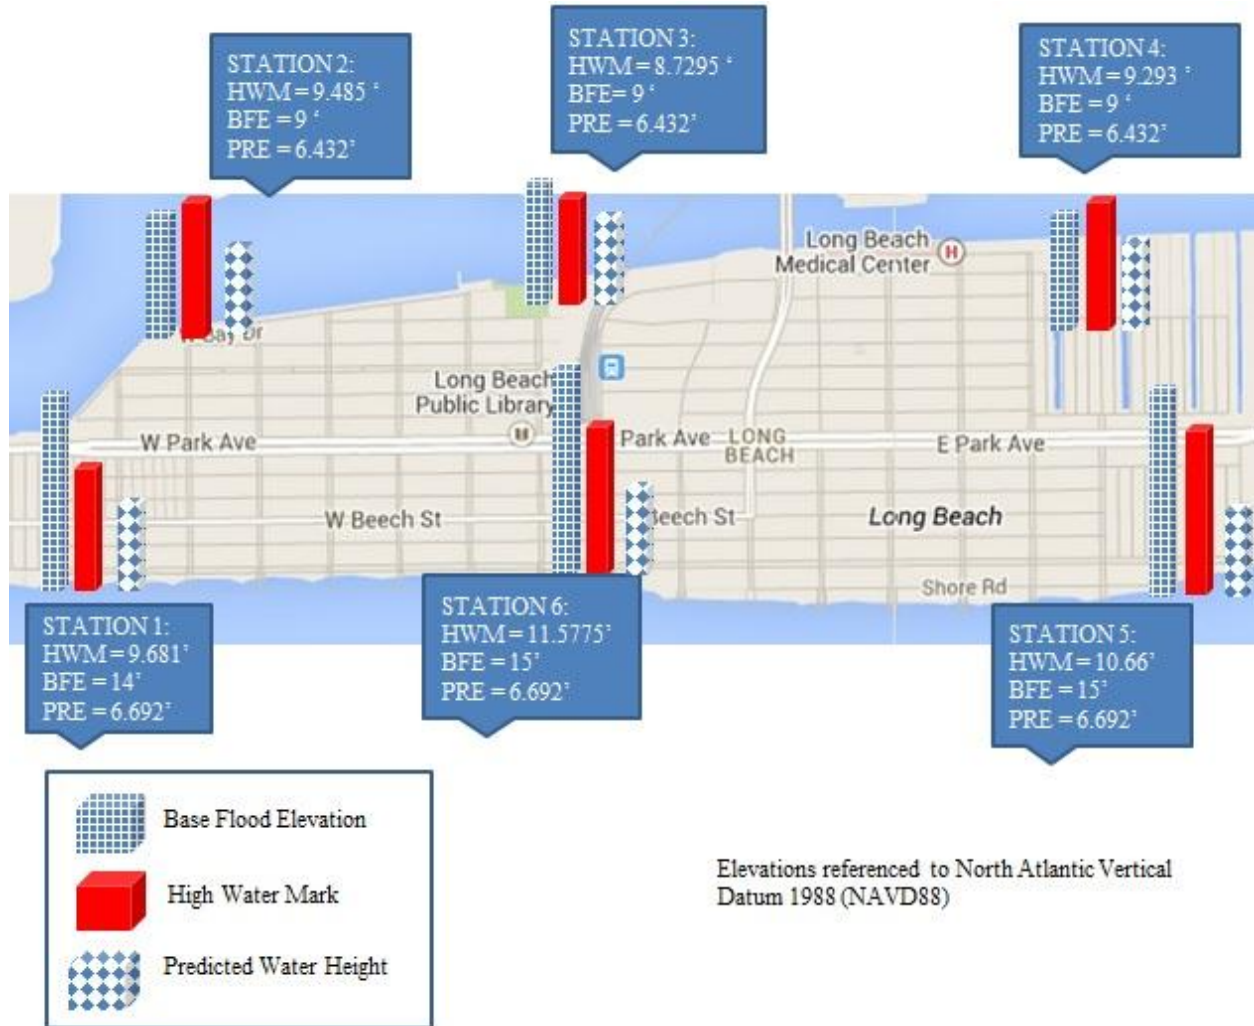
Figure 3 – Water height comparison for Long Beach during Superstorm Sandy

Figure 3 shows how the water heights varied throughout the city. The figure includes the predicted heights from NOAA (Table 1), and the zone’s base flood elevation, or BFE. The BFE is the elevation set by the Federal Emergency Management Agency (FEMA) at which a structure must be built in order to comply with building code standards. BFE’s are determined by examining water level data records. It is based off of the 100-year water levels, or the water level that has a 1% chance of occurring for a given year.

Figure 3 also compares the highest water surface elevations (high water mark, or HWM) reached at 6 different locations in Long Beach during Superstorm Sandy as recorded by temporarily deployed USGS gages, as well as the NOAA predicted water heights for that day (Table 1) and the FEMA BFE’s at the same locations. Places where the HWM exceeds the BFE experienced the most damage on the island. Since structures were built using FEMA BFE levels to avoid floods, these structures were not prepared for such high flood waters. The water caused damage to electrical systems or structural supports. At every storm gage’s location, the HWM exceeded the predicted water height significantly, as the predicted water height does not take into account wind forces or storm surges.

First consider total houses damaged per zone. Zone 1 had no houses damaged in the East or Central Zones. While surprising, it is important to recall the BFEs in this zone were actually several feet higher than the HWMs were here (recall Figure 3). These houses were designed with the expectation that water levels could indeed reach and exceed that which were

Zone 5 on the bayside had the most number of total houses damaged. Again, recalling Figure 3, the HWMs exceeded the BFEs in this zone and as such the houses experienced hydrostatic and buoyant forces during Superstorm Sandy that were greater than anticipated and provided for in the codes. From this data, it can also be seen that as each zone approached closer to the bay side, a greater number of houses were damaged.

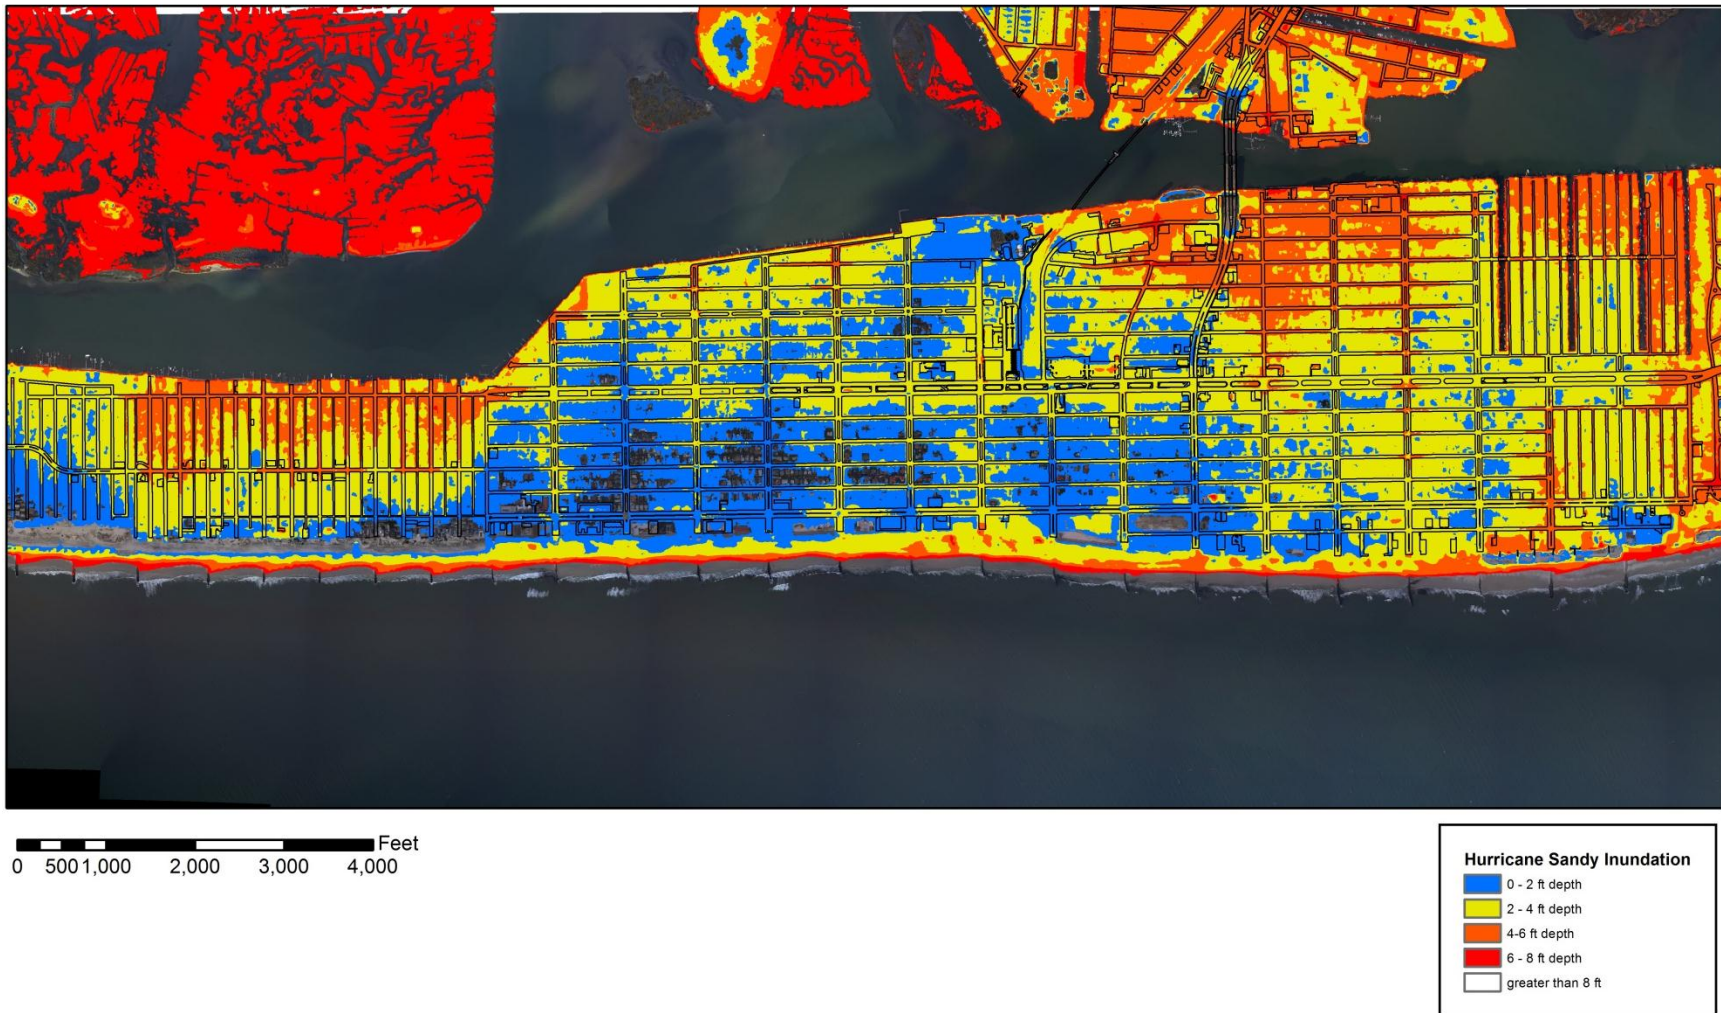
Figure 4 – Depth of Inundation during Superstorm Sandy.

Figure 4 displays the depth of the flooding – which subtracts the water surfaces reached from the storm from the ground elevations throughout the region. The greater the depth of water, the greater the hydrostatic forces experienced by the structure, and thus potential damages to structures. The areas that experienced the greatest depth of flooding inundation were the areas that bordered the intercoastal channel, or the north side of the city. The northeast and north-central sections of the city had many blocks with over 6 ft of water. Thus, the storm surge from Superstorm Sandy flooded the city via the bay side. The southeast section of the city which is closer to the Atlantic Ocean had many blocks that had less than 2 ft of water inundation.

The Central District had less than half the number of houses affected than both the West End and East End. When again referring to Figure 4, it can be seen that inundation levels were indeed the lowest in the Central District. Lower inundation levels lead to lower hydrostatic and buoyant forces on the structures, and thus fewer total houses damaged.

Inundation levels should also be considered, recalling Figure 4. Inundation heights on the bayside were higher and reached further extents than the inundation on the Oceanside. Thus houses in the bayside zones were exposed to larger hydrostatic and buoyant forces than houses on the Oceanside which had lower inundation levels.

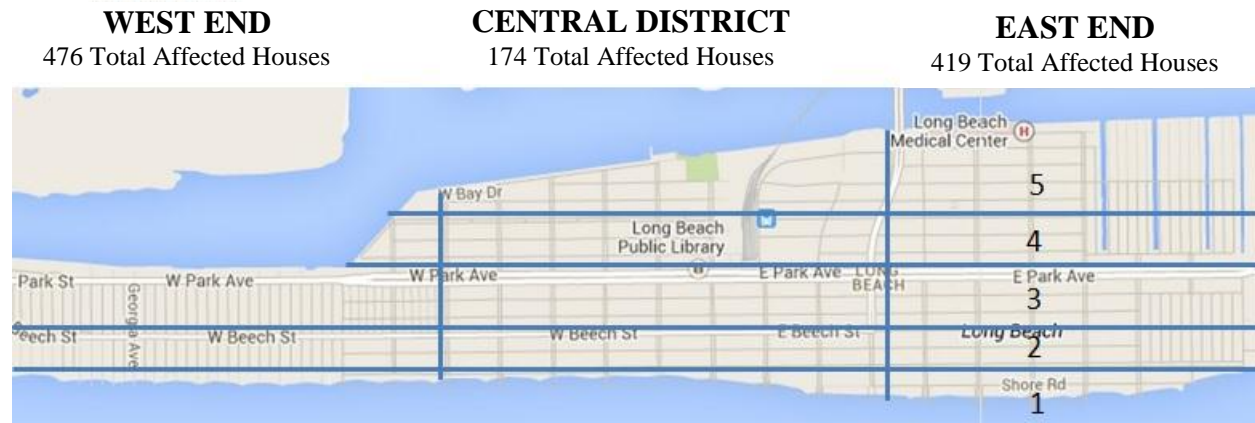
Figure 5 – Long Beach, New York when divided up into three sections (West End, Central District and East End) and zones 1-5

Figure 5 shows the division of Long Beach into 3 districts (West End, Central District, and East End) and 5 zones (numbered sequentially starting in the south going north) and indicates the number of homes damaged in each of the districts. Each zone and district was analyzed by Sustainable Long Island with respect to the economic status of the homes. The Manhattan College research team analyzed homes in the same domains. They further classified the homes as damaged during Superstorm Sandy such that homes that Sustainable Long Island categorized as either affected by the storm were now considered damaged. Houses that were classified as having a refuse container (“pod”) on site were assumed to be under construction to repair damages incurred during Superstorm Sandy. Houses that were originally classified as demolished were very few, and grouped together with the houses under construction for the structural assessment portion of the research. Houses that were classified as “for sale” or “vacant” were assumed to be so due to either real or perceived damage from the storm. It is recognized that the “For Sale” and “Vacant” categories may actually include some houses that were not physically damaged by the storm, but are simply for sale for other reasons, which may

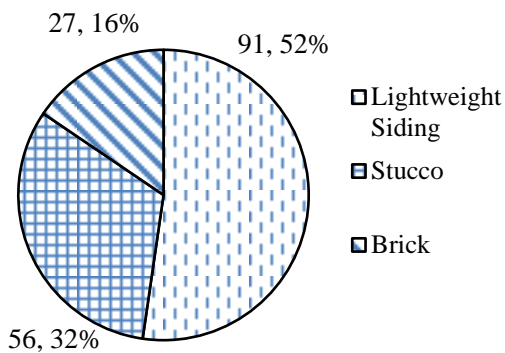
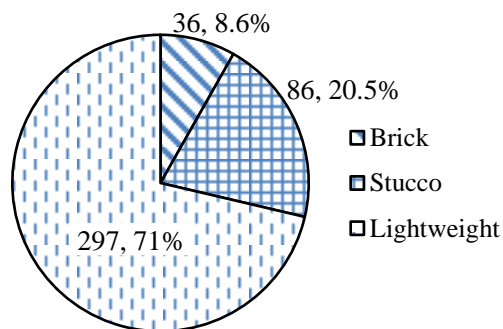
Figure 7 – A breakdown of total affected houses in the (a) Central District and (b) the East District

A comparison of the damage to these types of houses can be seen in Figure 7 – Central District details in part (a) and East End district details in part (b). Brick, stucco and lightweight siding houses have been divided up into houses that are for sale, vacant and in construction in the central district of Long Beach. The percentages of houses with lightweight siding that were affected far surpass the percentages of both stucco and brick houses, as they are the lightest and thus least resilient type of external cladding used in house construction studied here. The conclusion can be made that houses with lightweight siding suffered the most damage from Superstorm Sandy, whereas brick houses suffered the least.

Heavier building materials better resist uplift due to buoyant forces. Damage to a house can occur during storm inundation as buoyant forces cause uplift on a house, creating added stresses on the anchorage systems connecting houses to foundations. Heavier building materials also better resist overturning moment felt as hydrodynamic and hydrostatic forces push laterally on a structure. Overturning moment can also create stresses on the foundation anchorage systems. Heavier and stronger building materials (brick and stucco) will also resist damage to the external cladding systems, i.e. tearing of lightweight siding.

Houses classified as “lightweight siding” experienced the most damage in the Central and East Districts of Long Beach, NY. These houses are made with the most lightweight materials, and are more susceptible to buoyant, hydrodynamic, and hydrostatic forces. Typical lightweight siding may weigh less than 1 psf.
