# Michigan Case Study Field Research

RBDCC – Penn State University  
Brian Lieburn  
March 2016

- TEETH Project – Midland MI
  - Moisture performance comparison of 2x4 and 2x6 walls
  - Forensic Investigation
  - Air Leakage Tests

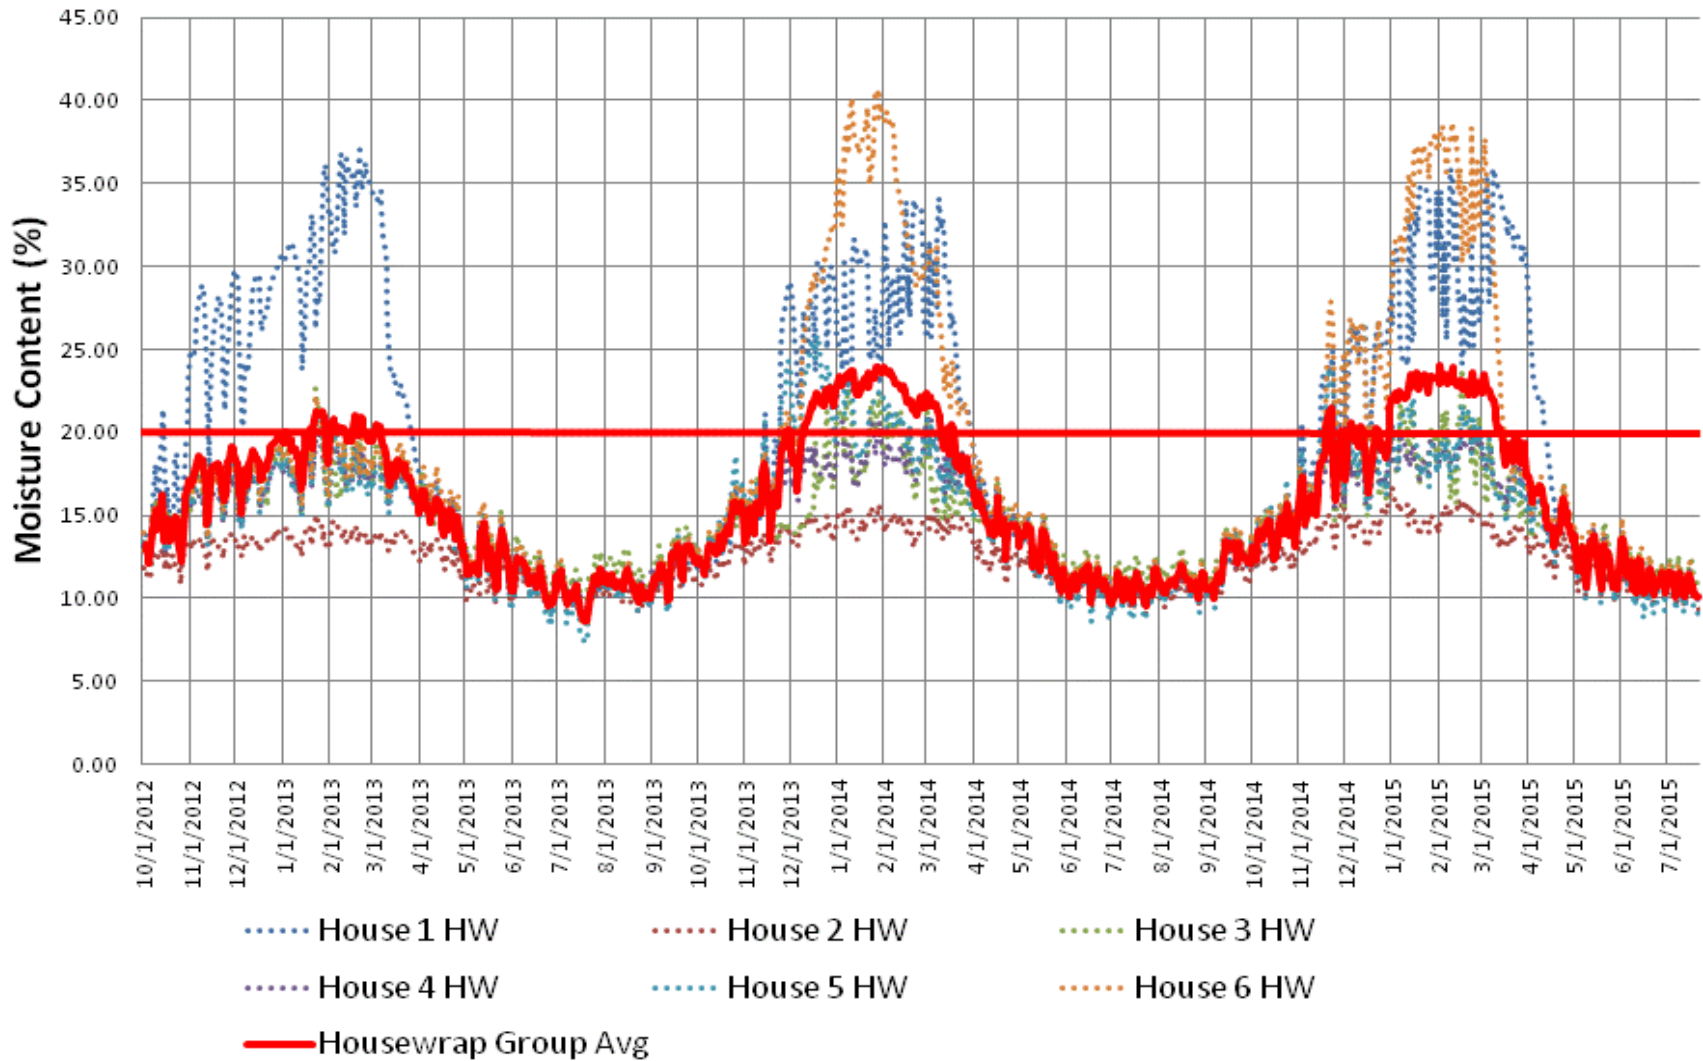
## Moisture Content - Housewrap Group Band Joist Interior Surface

- **Yikes, high MC for much of the winter in some 2X6/Housewrap houses. Let's cut into them and see if they are deteriorating.....**

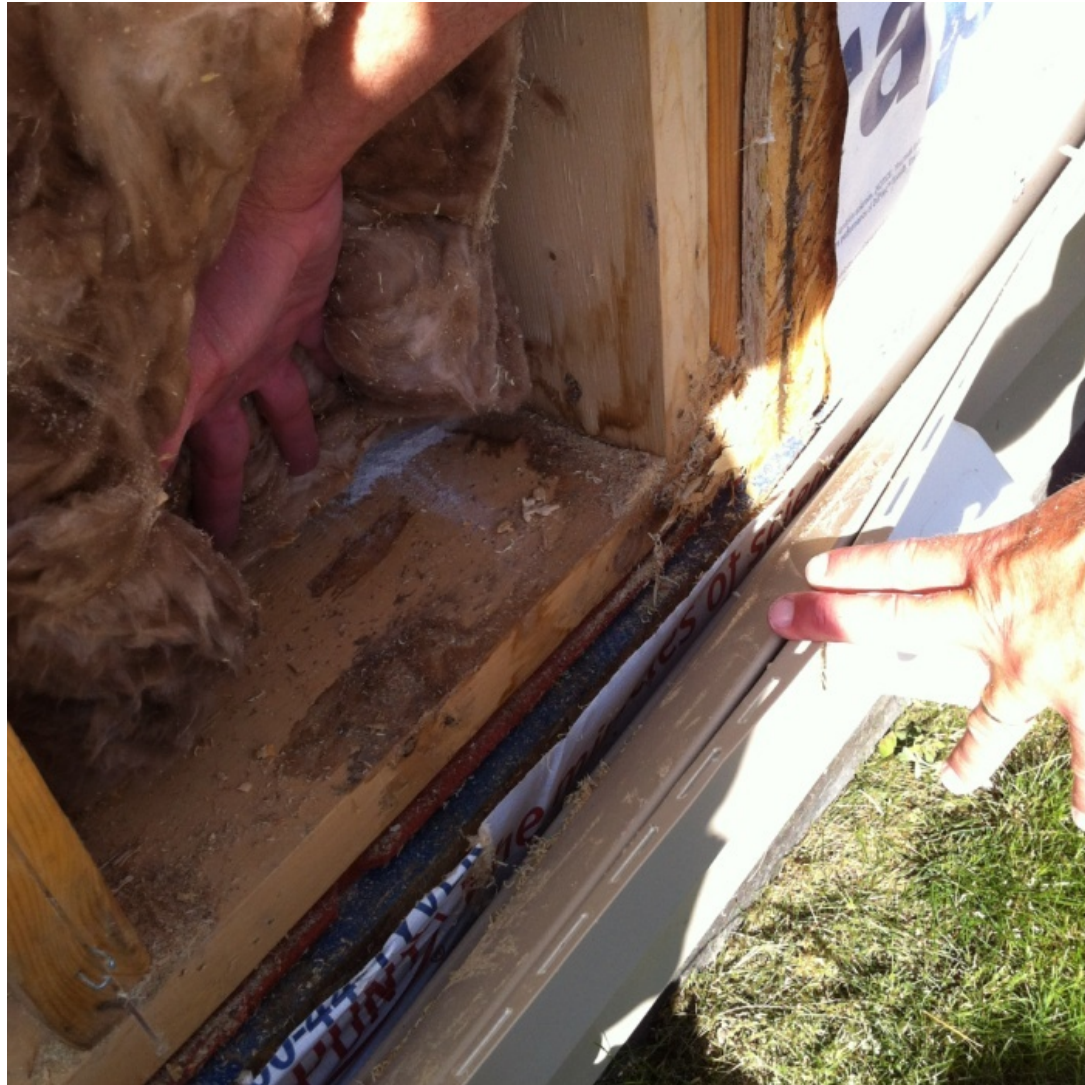
## House 2

Moisture Content	Above Grade Wall	Rim Joist	Microbial Sampling
House 2	Elevated	Water staining in cavity	No evidence of water	Moderate to heavy fungal growth – wall cavity
House 3	Elevated	Small area of dark staining	No evidence of water	Some fungal growth – rim joist
House 6	Elevated	No evidence of water	Some staining on joist bottom chord	Some fungal growth – rim joist
House 5	Low	Water staining in cavity	Rust on staples	No fungal growth

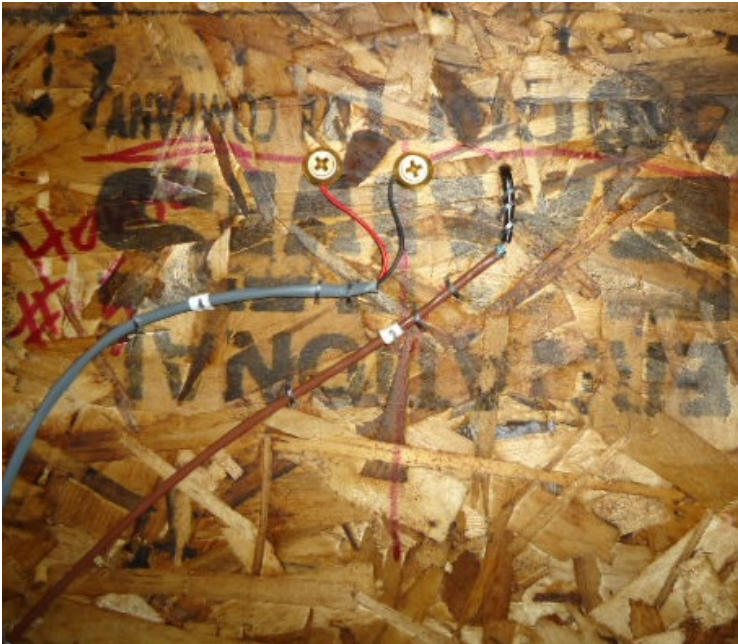
2011

# House 5 Rim Joist

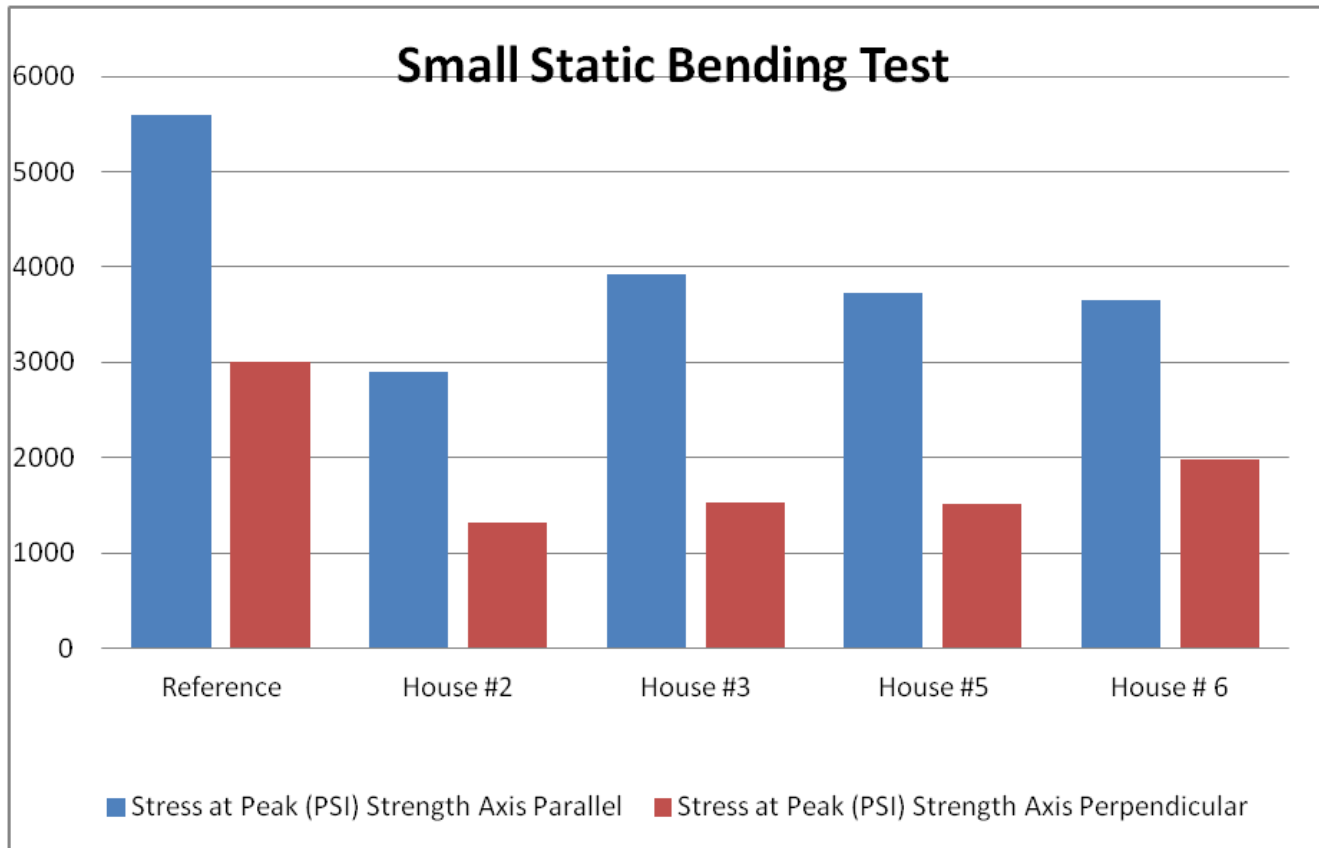
# OSB Strength Measurement after 4 years.

PS2 -  
Performance  
Standard for  
Wood-Based  
Structural  
Panels

4.5"x 14"  
ASTM D3043.  
Method D

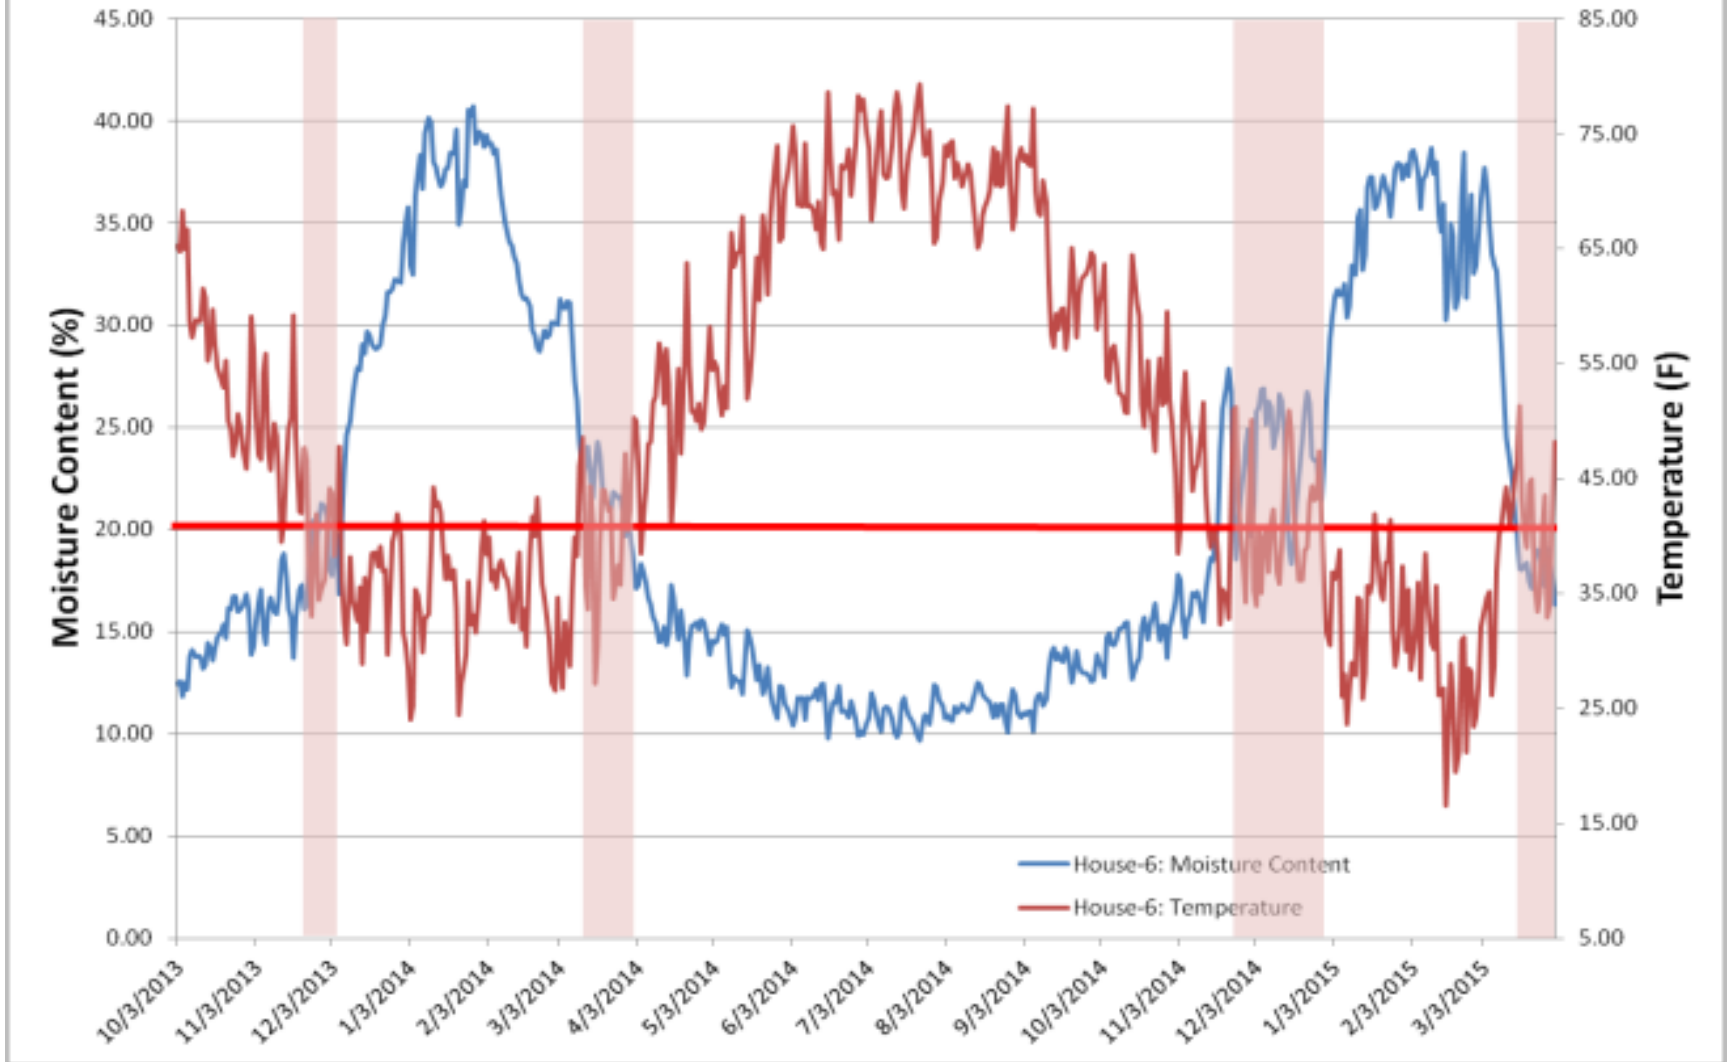
## Temperature and Moisture Content - House 6 OSB/Wrap - Band Joist Surface

**— So, Why do we see this – high MC but no real deterioration?**

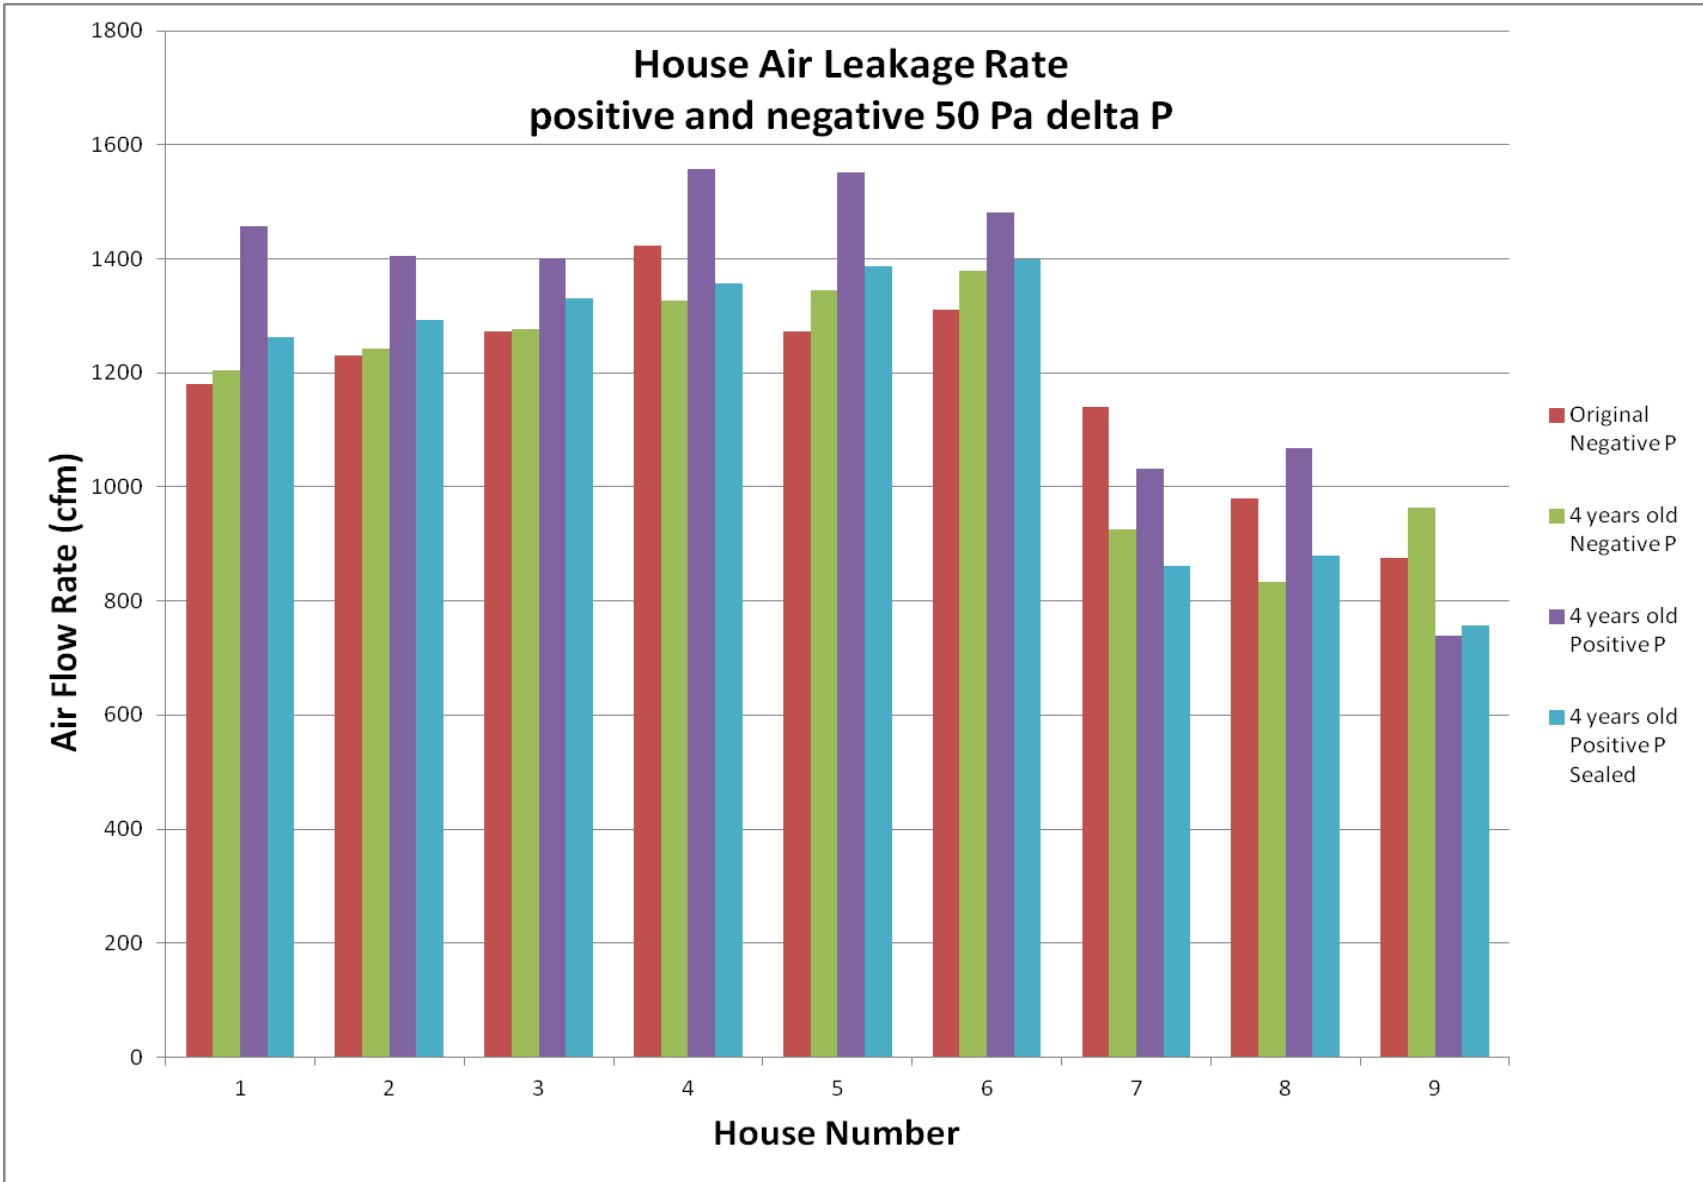
## Repeat Blower Door Test

- Original tests, 2<sup>nd</sup> half 2011
  - Only negative 50 Pa delta P
- Recent tests, 2<sup>nd</sup> half 2015
  - Repeat negative 50 Pa delta P
  - Positive 50 Pa Delta P
  - Positive 50 Pa Delta P, but with sealed penetrations (i.e. bath fans, etc)
