The Unsealing of Naturally Aged Asphalt Shingles: An In-situ Survey

C. R. Dixon¹, D.O. Prevatt¹, F.J. Masters¹, and K.R. Gurley¹

ABSTRACT

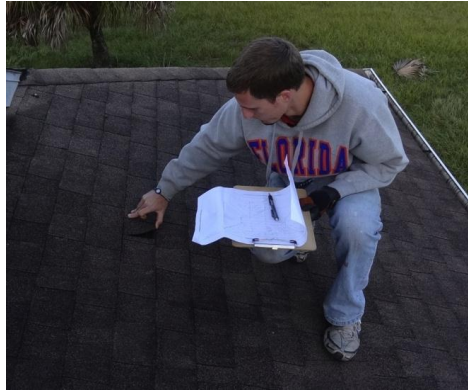
Figure 2. Partially unsealed field shingle discovered during a survey.

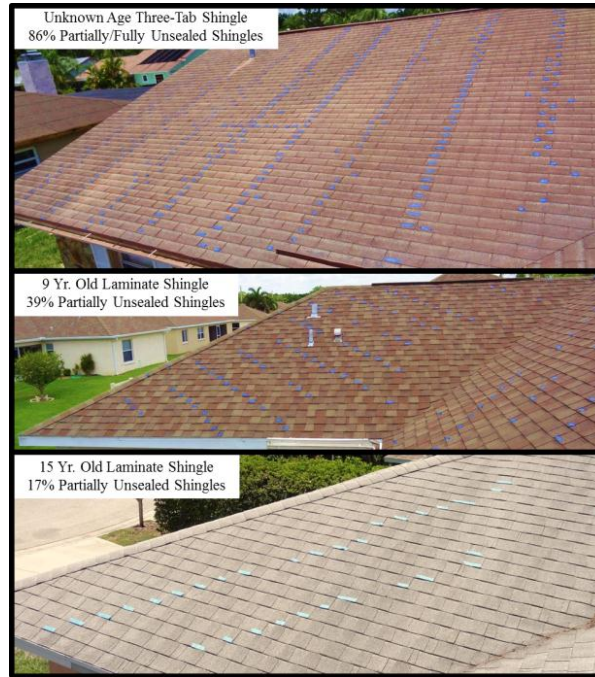
Two distinct, nonrandom, patterns of partially unsealed shingles were observed on 70% of the roofs surveyed and were found on both three-tab and laminate shingle systems. As shown in Figure 3, the patterns (marked with blue painter's tape) corresponded to the method of shingle installation. Vertically installed shingles (i.e., raked) had vertical patterns of partial unsealing, while diagonally installed shingles had diagonal patterns of partial unsealing. Given the random nature of selecting roofs to survey these patterns are likely independent of shingle manufacturer and installer. The newest roof that contained the unsealing patterns was six years old, and the total percentage of shingle strips containing the unsealing patterns – for known roof ages – ranged from less than 1% for a six year old roof to over 79% for a 20 year old roof (Figure 3).

Figure 3. Patterns of partially/fully unsealed three-tab and laminate shingles. (Note: blue tape denotes location of unsealing).

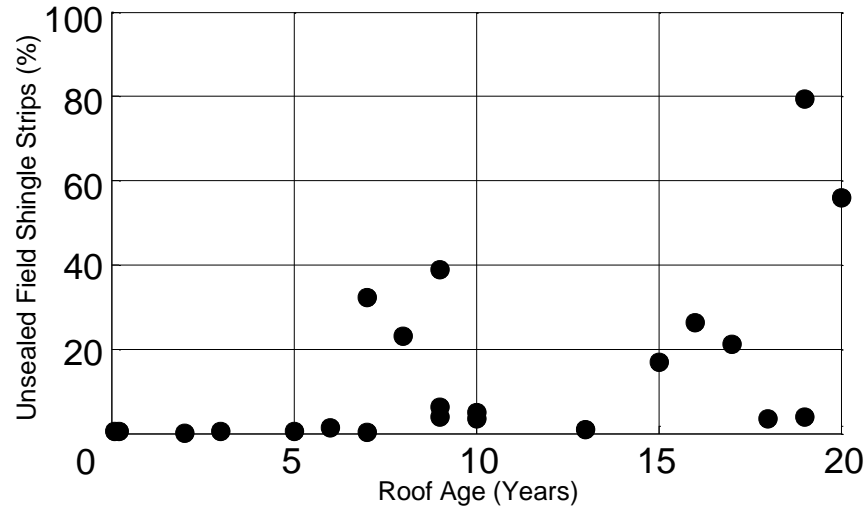
To evaluate the role of natural weathering on the observed unsealing, the age of each shingle roof surveyed was determined from publicly available building permit records and information provided by the homeowner. Unsealing statistics from surveys conducted on roofs with unknown ages were not included in this analysis. For each home, the total percentage of unsealed shingle strips – either fully or partially – was calculated by dividing the count of the total number of shingle strips with unsealing by the total number of strips installed on the roof. The total percentage of unsealed shingle strips stratified by roof age is shown in Figure 5. The plot indicates a

general increase in the percentage of unsealed shingles as the roof age increases. Recall, unsealing patterns were not observed on roofs less than six years old. The total percentage of unsealing for all roofs with less than six years of aging is less than 1% while roofs with greater than six years of aging had up to 79% of the shingle strips with either full or partial unsealing. The variability of data set appears to increase with roof age as well.

Figure 5. Percent of unsealed shingle strips located in the field of the roof versus roof age. (Note: fully and partially unsealed shingles combined)

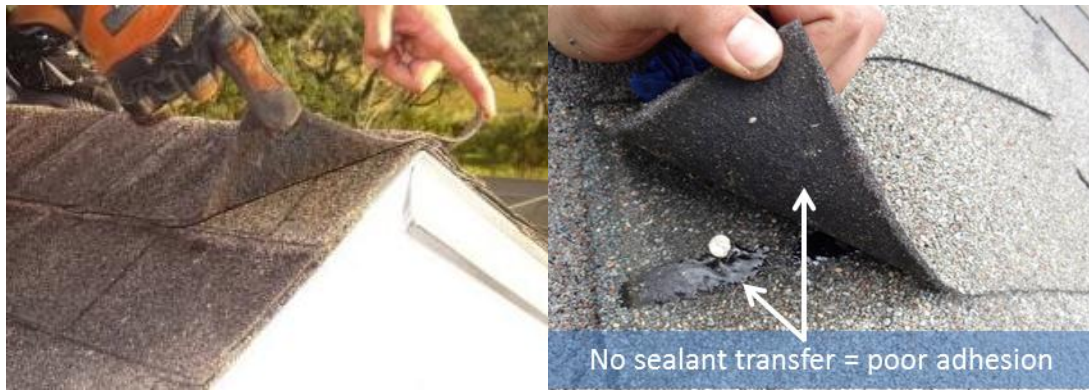
Unsealed hip and ridge cap shingles can be classified into two categories: (1) lack of sealant under the leading edge of the shingle cap (Figure 6a), or (2) adhesive failure between the sealant and underside of the cap near the cap's edge (Figure 6b). The lack of sealant can be attributed to the installation method of the shingle system, while the adhesive failures indicate that the cap shingles suffer from a weak bond between the sealant and underside of the cap. The adhesive performance of the sealant located directly on the hip/ridge line was superior to the adhesion towards the edges of the cap.

Figure 6. Typical unsealed ridge and hip cap shingle conditions: (a) no sealant strip below cap and (b) poor adhesion on edges of cap.

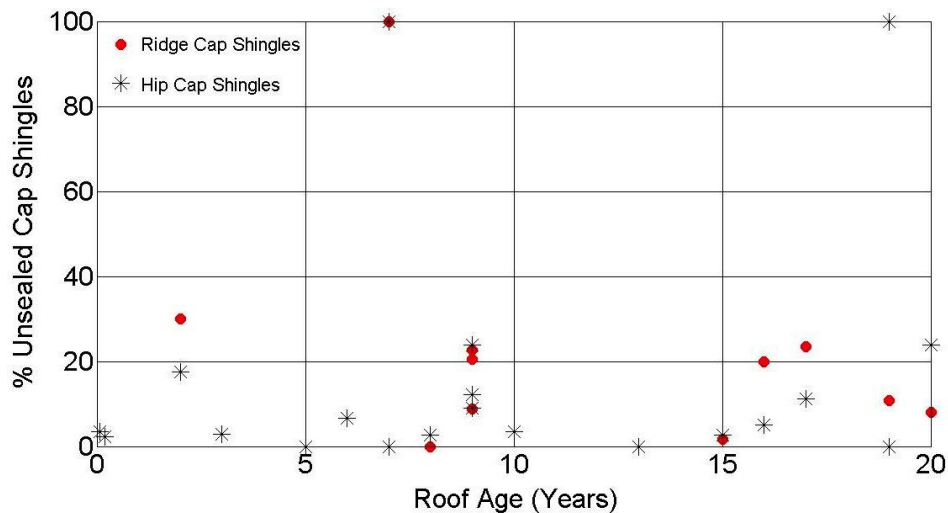
Figure 7. Percent of fully/partially unsealed cap shingles (hip and ridge) versus roof age.

the context of shingle age it is apparent that no correlation exists between roof age and the percentage of unsealed caps (Figure 7). As expected, hip and ridge cap shingles are equally as likely to be unsealed. Aside from the cap shingles that did not have sealant below their leading edge, the total percentage of unsealing for caps ranged from 0 – 30%.

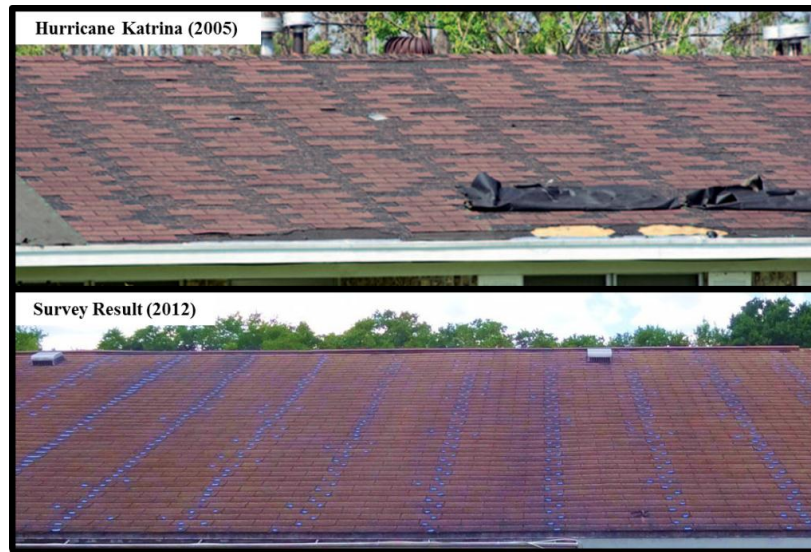
Second, the impact of unsealed asphalt shingles on the wind performance of shingle roofs has not been addressed in previous literature. Post-storm damage assessment reports provide the most relevant information; however, their conclusions contain uncertainty as the condition of the damage roof prior to the storm is unknown. Reports by FEMA (2005a, 2005b, 2006, 2009) have consistently noted asphalt shingle wind damage patterns that have striking similarity to the partially unsealed shingle patterns observed in this study (Figure 8). These failures are most often attributed to a lack of fasteners on the end joint of the shingle due the racked installation method. However, as the sealant strip is the primary load path, unsealing of the sealant strip is required before nail placement becomes an issue. Hip and ridge cap failures are the most frequently reported asphalt shingle-related failures in post-storm reports (FEMA, 2005a). The failures are attributed to poor adhesion between the cap and the sealant strip (FEMA, 2005a) – echoing the findings of this study.

Figure 8. Potential link between (top) post-hurricane Katrina damage observed by FEMA (2012) and (bottom) observations of pre-existing unsealing during roof surveys.
