# A Review of Research Conducted to Determine the Effectiveness of Air Barrier Installations

Mr. Peter Spafford

*Air Barrier Association of America, Inc.*

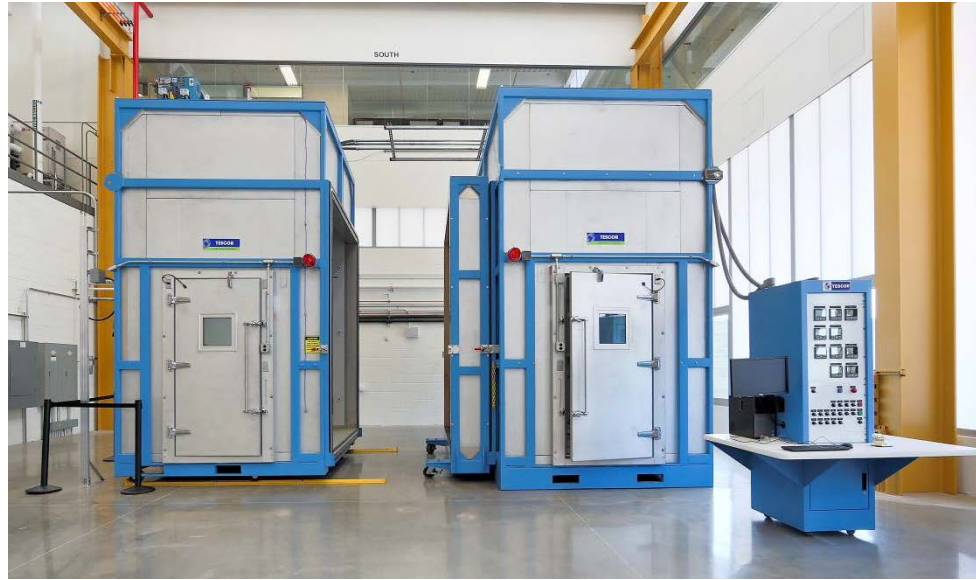
# ORNL Wall Air and Moisture Penetration Test Chamber

## Parameters

- Temperature
- Relative humidity
- Pressure
- Rain
- Infrared radiation
