Superstorm Sandy Storm Surge and Residential Damage Correlation – A case study of Long Beach, NY

N.L. Braxtan, Ph.D.¹, K. Donohue-Couch, M.S., P.E.², and K. Westphal³

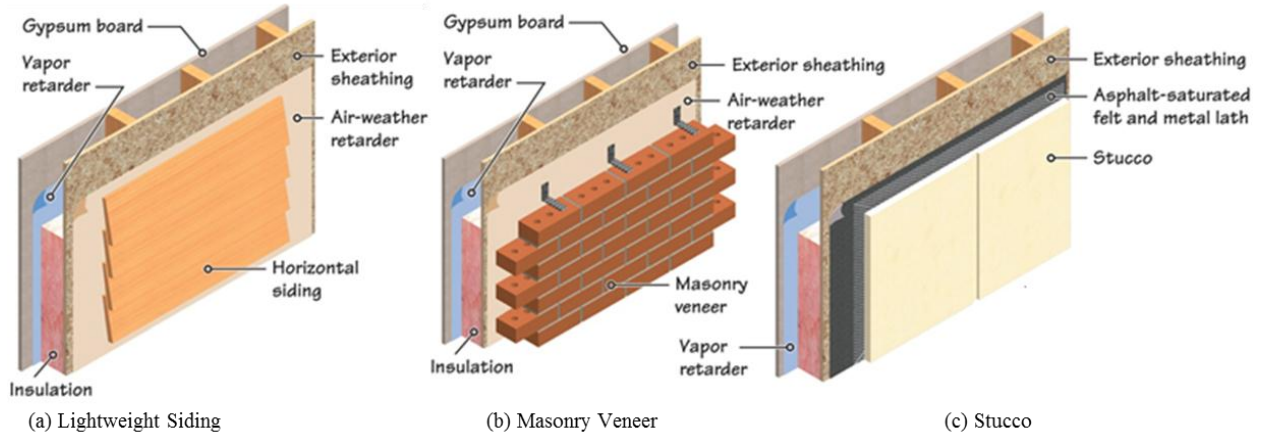
Figure 6 – Typical composition of residential buildings (Mehta et al., 2013)

Houses were classified as lightweight siding, stucco, or brick (masonry) facades. Lightweight siding includes all houses with vinyl siding, aluminum siding, or shingles visible from the outside of the house. Stucco houses consist of those that have an adobe-type exterior, with more of a flat, textured surface acting as one slab rather than strips of siding. Brick houses have a masonry façade. Figure 6 shows examples of the external wall systems of typical houses with siding, brick, and stucco. Each of these types of houses was assumed to be internally constructed as a typical wood light frame structure.

Heavier building materials better resist uplift due to buoyant forces. Damage to a house can occur during storm inundation as buoyant forces cause uplift on a house, creating added stresses on the anchorage systems connecting houses to foundations. Heavier building materials also better resist overturning moment felt as hydrodynamic and hydrostatic forces push laterally on a structure. Overturning moment can also create stresses on the foundation anchorage systems. Heavier and stronger building materials (brick and stucco) will also resist damage to the external cladding systems, i.e. tearing of lightweight siding.

Houses classified as “lightweight siding” experienced the most damage in the Central and East Districts of Long Beach, NY. These houses are made with the most lightweight materials, and are more susceptible to buoyant, hydrodynamic, and hydrostatic forces. Typical lightweight siding may weigh less than 1 psf.
