# Michigan Case Study Field Research

RBDCC – Penn State University  
Brian Lieburn  
March 2016

- TEETH Project – Midland MI
  - Moisture performance comparison of 2x4 and 2x6 walls
  - Forensic Investigation
  - Air Leakage Tests

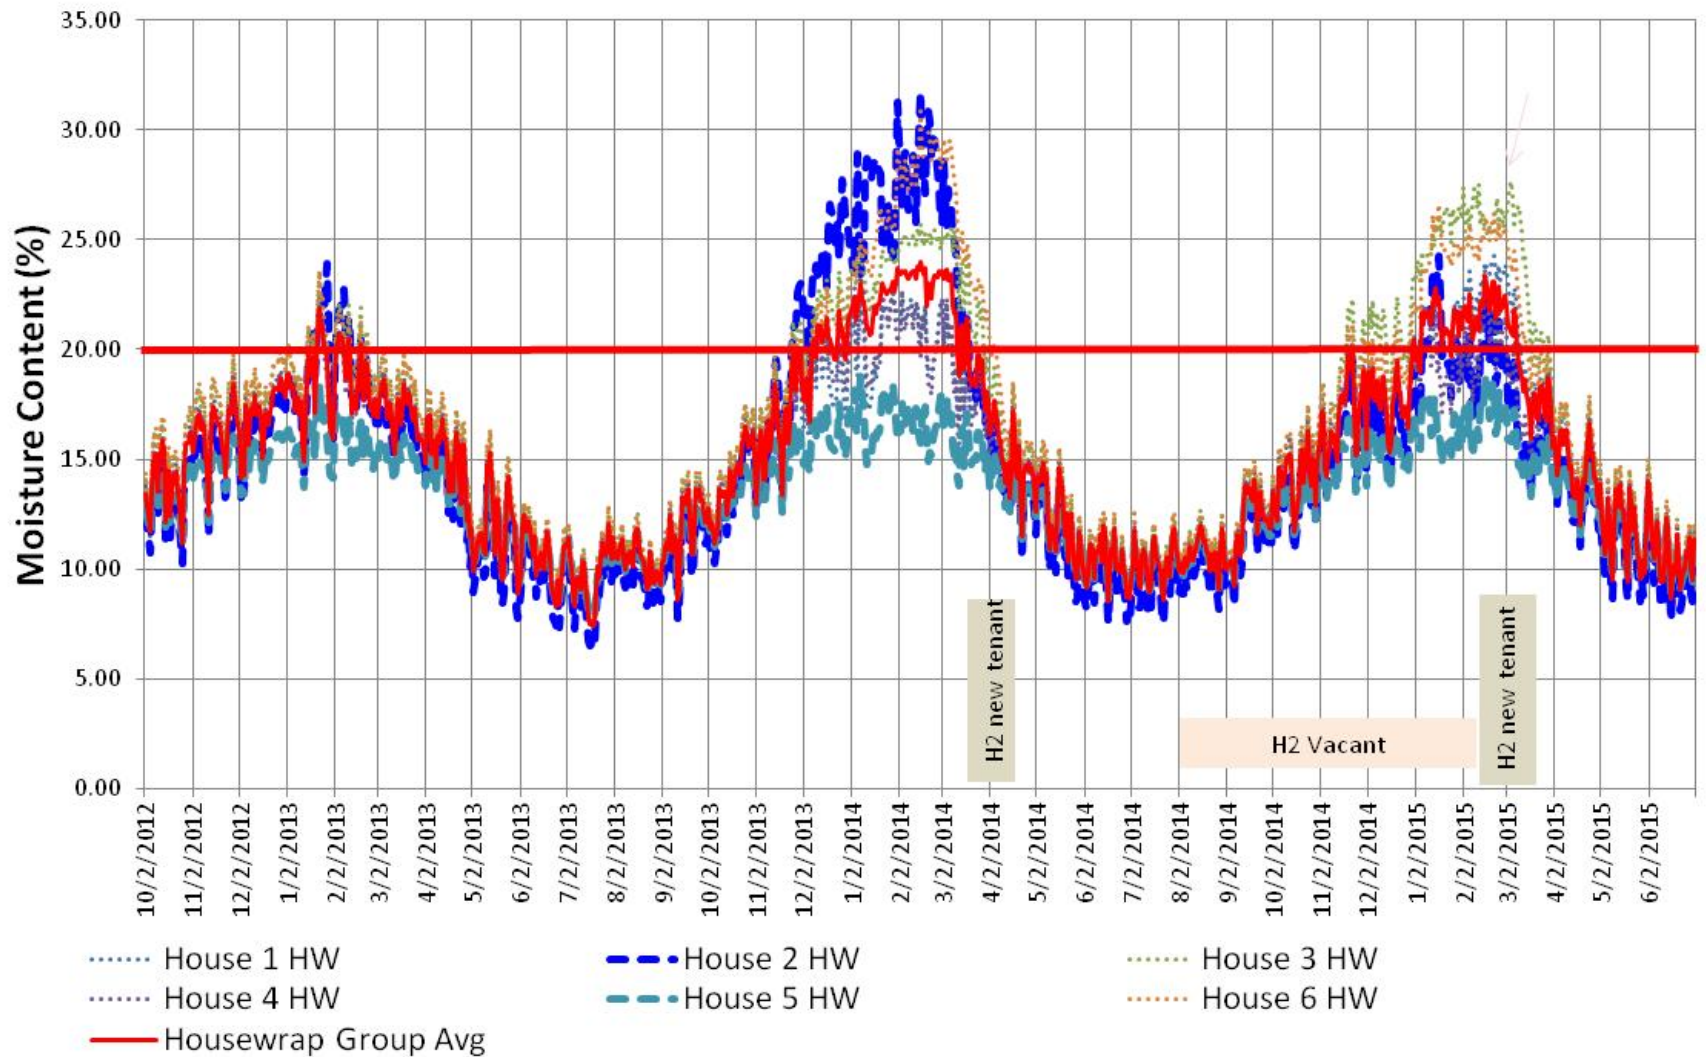
# Moisture Content - Housewrap Houses Interior Sheathing Surface - Above Grade Cavity

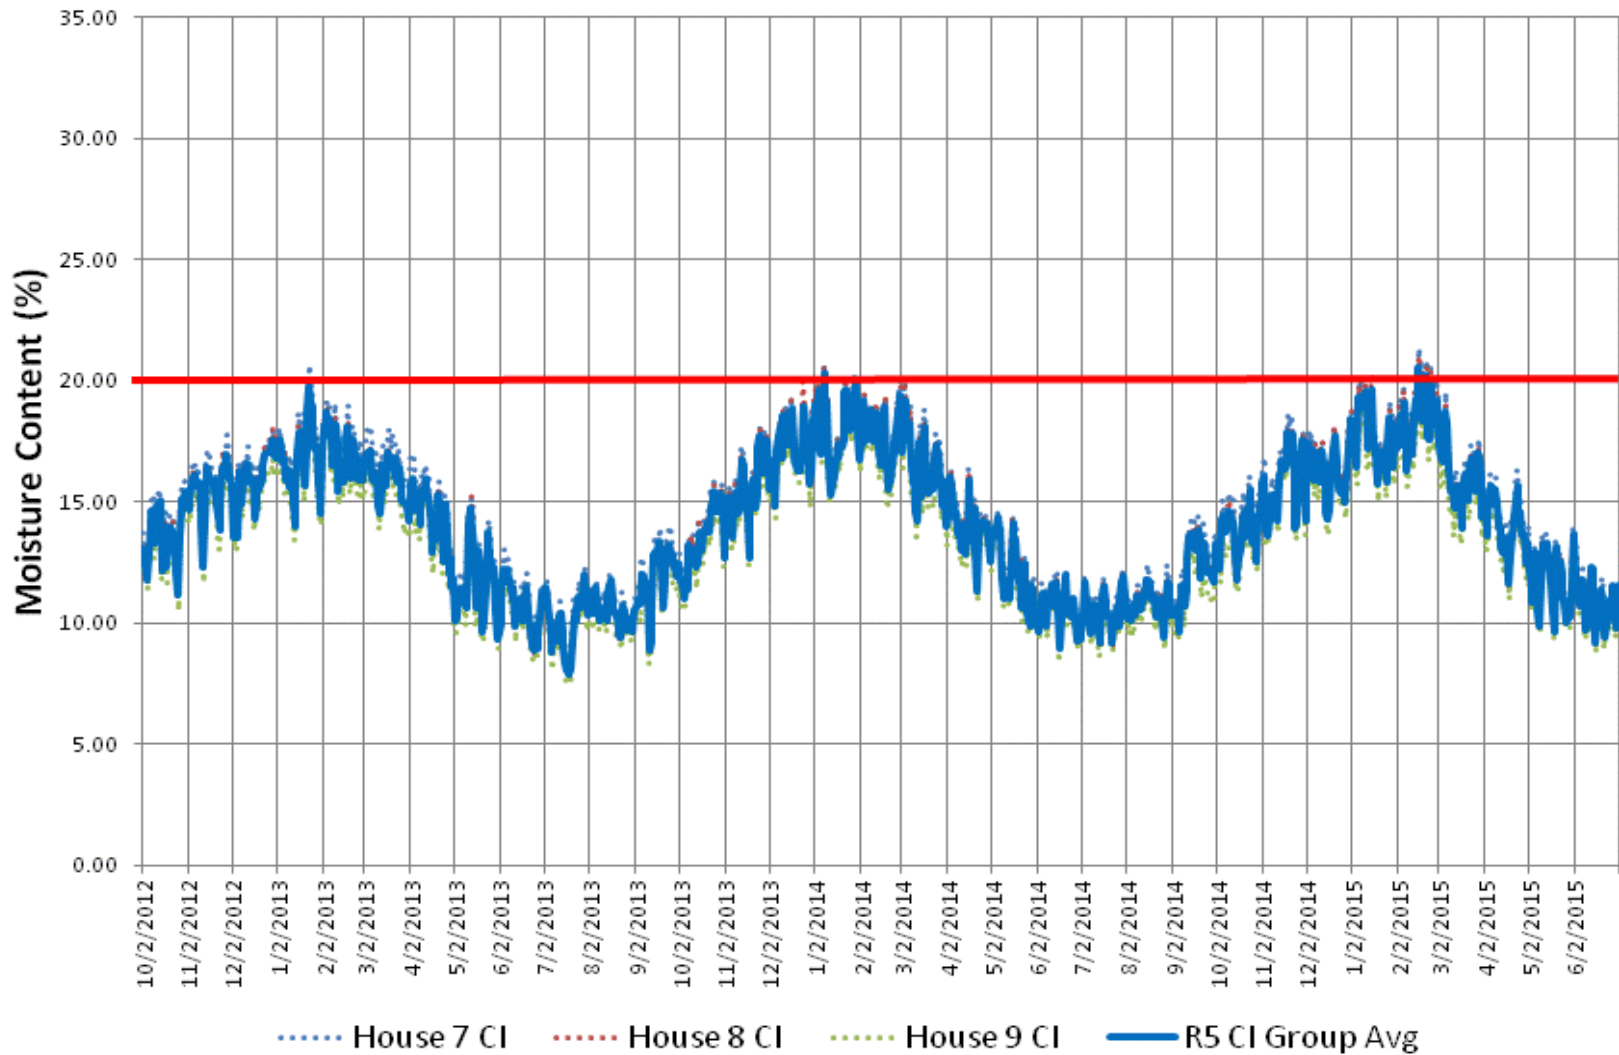
## Moisture Content- R5 CI Houses Interior Sheathing Surface - Above Grade Cavity

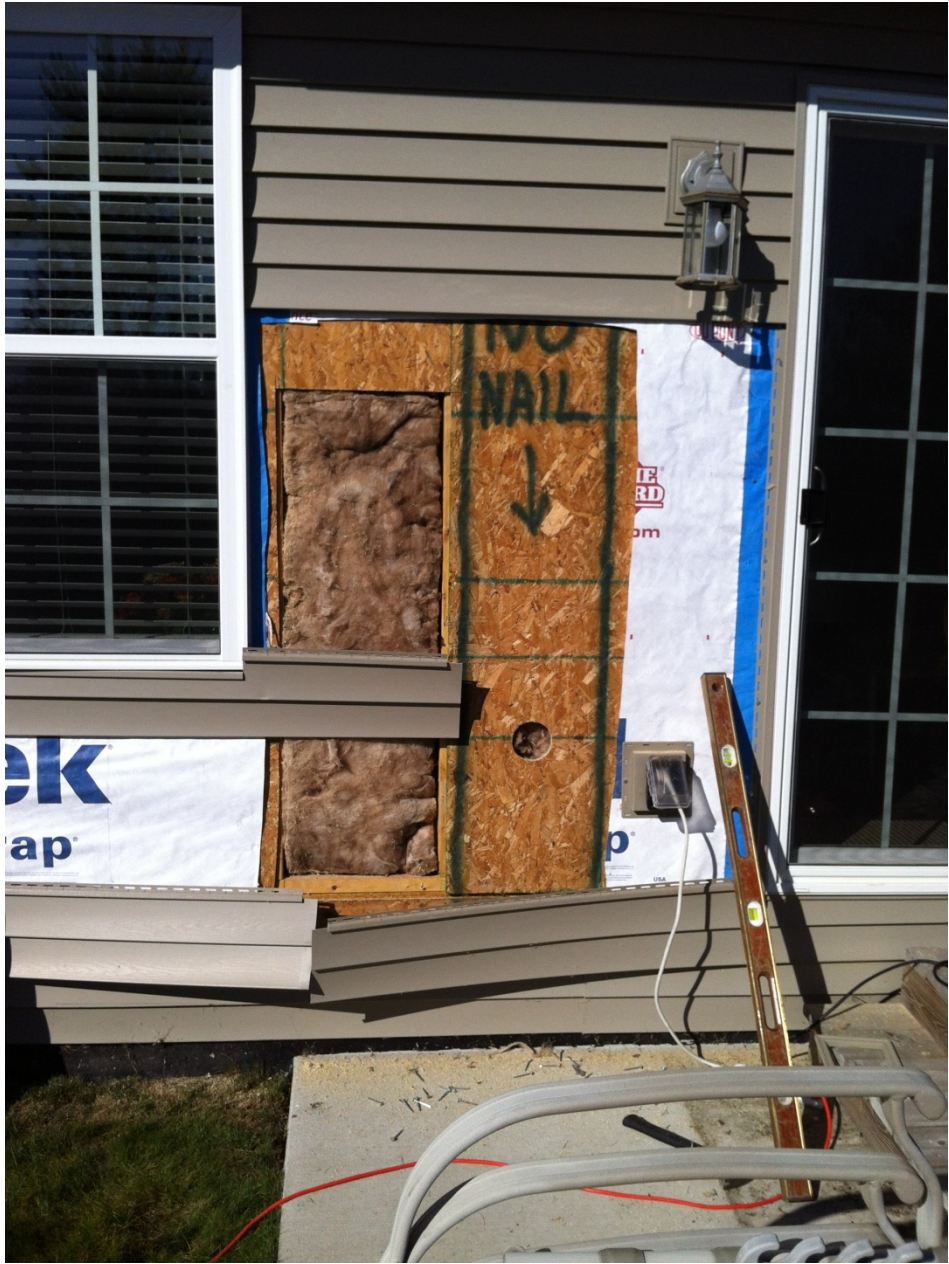
- Inspect Houses **2,3,6** - elevated measured moisture content
- Inspect House **5** - measured moisture content always below 20%

- Inspections
  - Visual Observation
  - Sampling of OSB for Strength Measurement
  - Swab for Fungal or Microbial Growth – including microscopy
